VOLUNTARY SAFETY RECALL CAMPAIGN 2022 PATHFINDER; DRIVER SIDE 2ND ROW CAPTAIN'S CHAIR SEAT FRAME INSPECTION

CAMPAIGN ID #: PC845 APPLIED VEHICLES: 2022 Pathfinder (R53)

NOTE: This bulletin only applies to the driver (LH) side 2nd row captain's chair seat assembly.

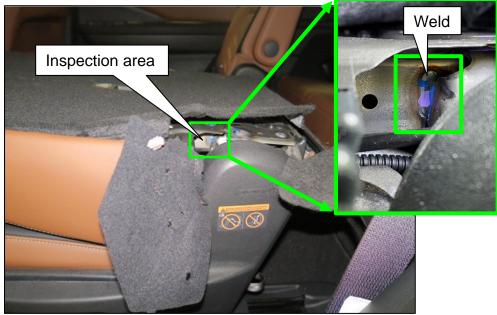
8. Using a suitable light source, look in the area shown in Figure 7 to locate the weld to be inspected.

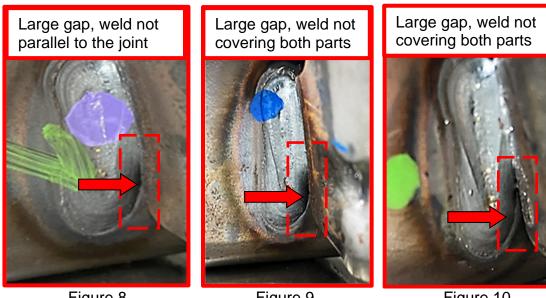
Figure 8

- o The weld should evenly cover both parts of the joint.
- The weld should run the entire length of the joint.
- The weld should run parallel to the joint.
- The weld should <u>not</u> have any cracks or separations between the two parts.

No Good (NG) Conditions

- 9. Inspect and compare the weld to the No Good (NG) examples (Figures 8 13 on page 6) and the OK examples (Figures 14 16 on page 7).
 - If the weld is found to be OK, reassemble the seatback in the reverse order of disassembly, and then skip to the **CLAIMS INFORMATION** on the last page.
 - If the weld is NG, proceed to step 10 on page 8 to determine the correct captain's chair seat assembly part number for ordering.
