RECALL CAMPAIGN BULLETIN

BT21-019 NTB21-090 September 23, 2021

VOLUNTARY SAFETY RECALL CAMPAIGN 2022 PATHFINDER; DRIVER SIDE 2ND ROW BENCH SEAT FRAME INSPECTION

CAMPAIGN ID #: PC846

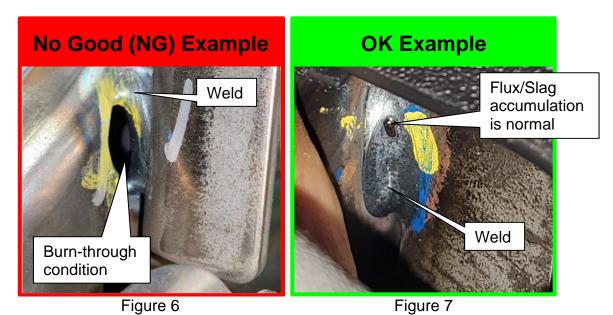
- 5. Inspect the weld for a burn-through condition (a visible hole in the weld).
 - If the weld has a burn-through condition (Figure 6), continue to step 6 on page 5 to determine the correct bench seat assembly part number for ordering.
 - If the weld does <u>not</u> have a burn-through condition (Figure 7), skip to CLAIMS INFORMATION on the last page.
