RECALL CAMPAIGN BULLETIN

| Classification: BT21-017 | Reference: NTB21-088 | Date: September 23, 2021 |

VOLUNTARY SAFETY RECALL CAMPAIGN 2022 PATHFINDER; PASSENGER SIDE 2ND ROW CAPTAIN'S CHAIR OR BENCH SEAT FRAME INSPECTION

CAMPAIGN ID #: PC847
APPLIED VEHICLES: 2022 Pathfinder (R53)

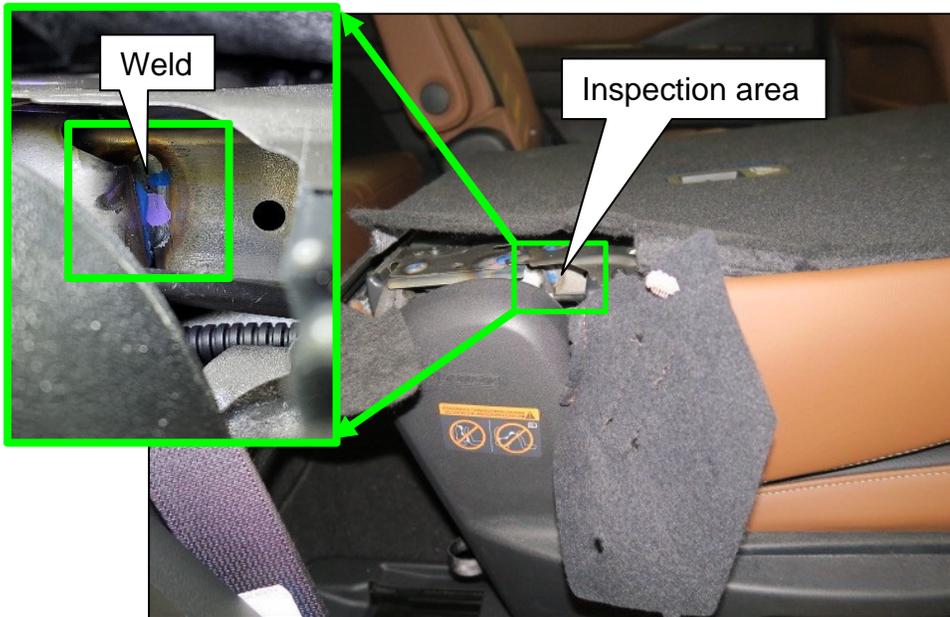
8. Using a suitable light source, look in the area shown in Figure 7 to locate the weld to be inspected.

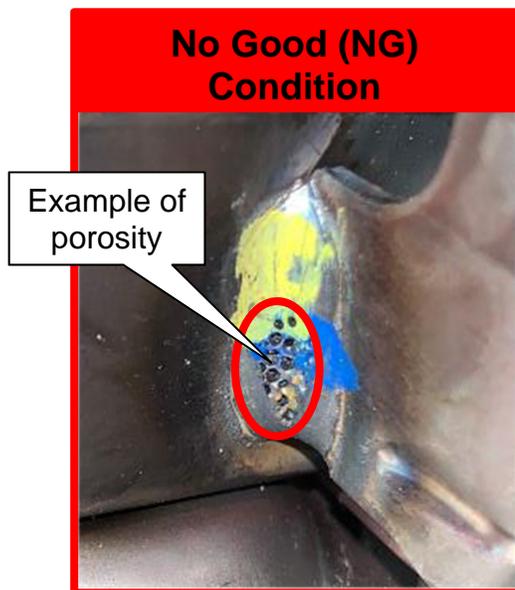
Figure 8

9. Inspect the weld for porosity or pitting.
- If the weld has signs of porosity (Figure 8), continue to step 10 on page 6 to determine the correct seat assembly part number for ordering.
 - If the weld does not have signs of porosity (Figure 9), reassemble the seatback in the reverse order of disassembly and skip to **CLAIMS INFORMATION** on the last page.

25. Replace the RH 2nd row seat assembly.
- Refer to the ESM: **BODY INTERIOR > SEAT > REMOVAL AND INSTALLATION > SECOND ROW SEATS > Removal and Installation**
