# Stop Delivery

*Taycan (1YA / 1YB), 2020-2022*

AMC1 Stop Delivery – Hazard Warning Lamp – automatic activation re-programming

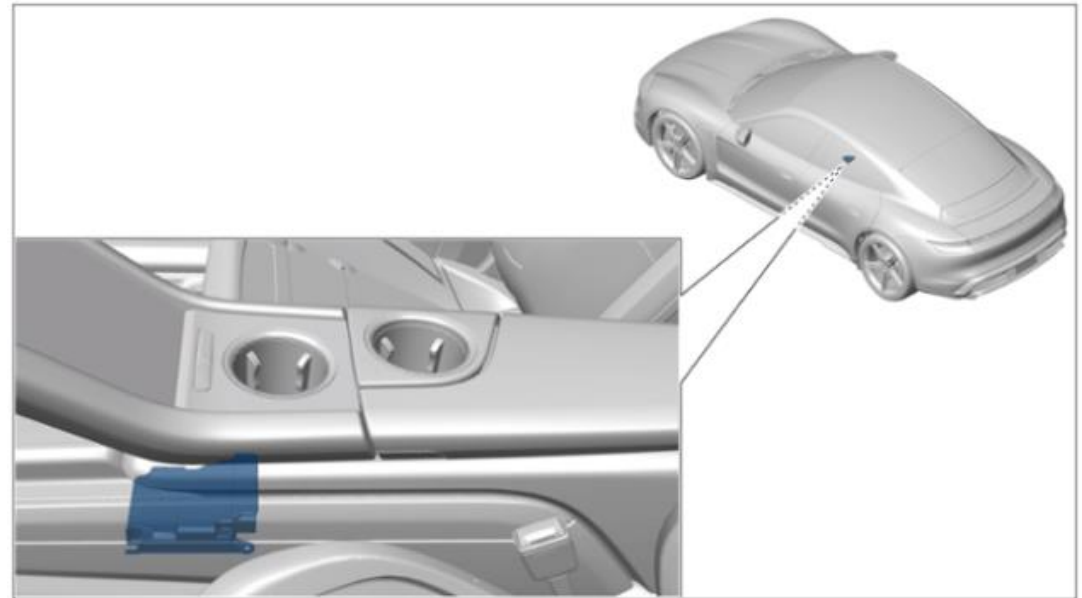
(1) Airbag control unit (**Re-coding**)

Affected vehicles may have been equipped with incorrect coding rules, which might cause an activation of the hazard warning lights by automatic means.

This is part of specific assistance features in other markets but is not permitted by local U.S. regulations.

To correct this behavior and to bring affected vehicles into regulatory compliance, the Airbag control unit has to be re-coded with an updated software before vehicle delivery.
