# Recall Notice Service Bulletin 514501 Rev. A

NHTSA Recall #: 21V817  
Transport Canada Recall #: 2021-636

Applicable for Chevrolet Traverse Power Infloor  
Conversions manufactured November 9, 2020 to  
September 10, 2021

# Chevy Traverse Screw Removal and Transmission Case Inspection 514501 Rev. A

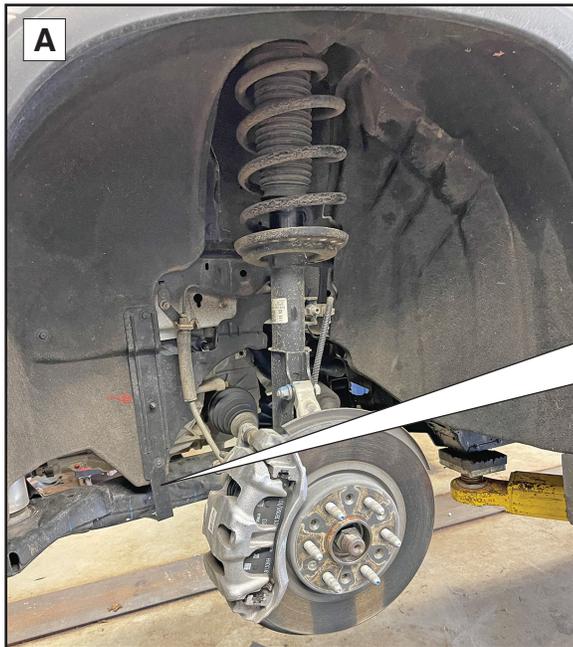
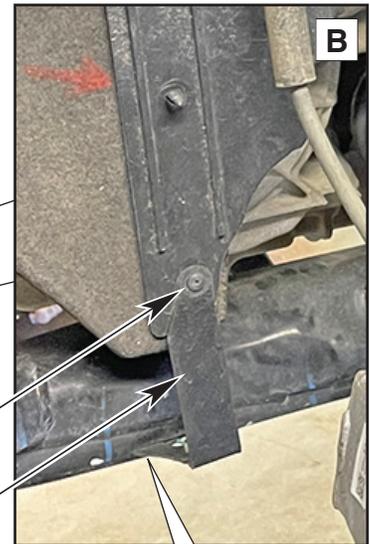
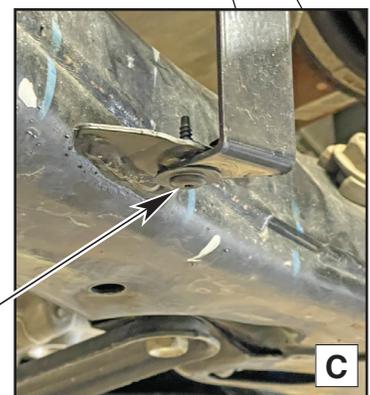
Screw  
L-Bracket

Screw

2. Remove wheel well liner L-bracket. See  
Photos A through C.

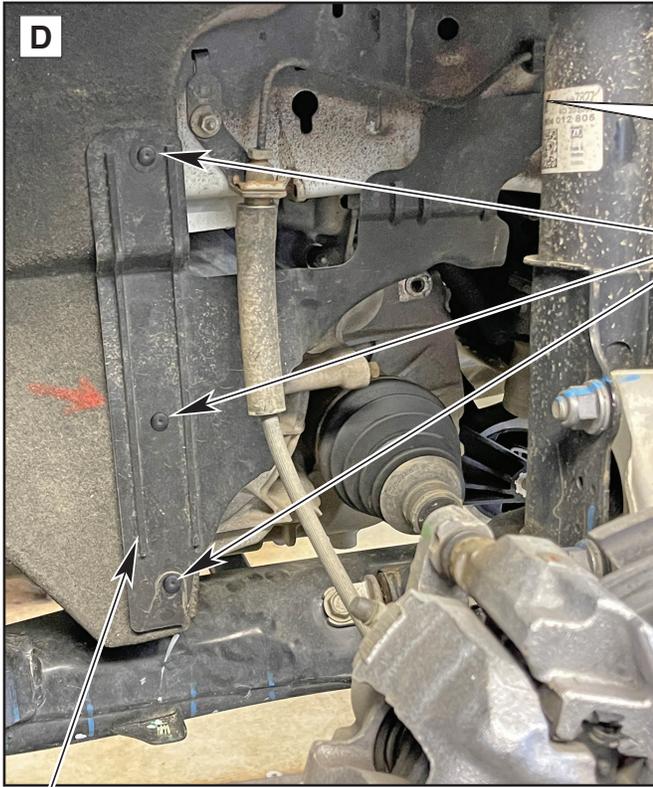
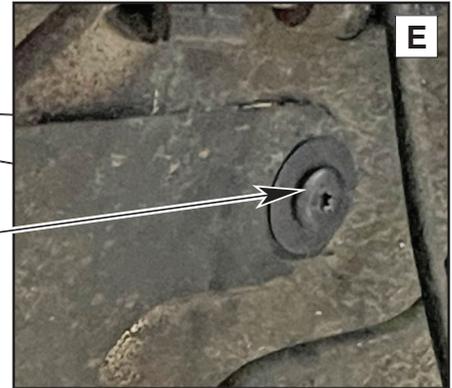
Wheel Well Liner Support Bracket

Screws

3. Remove wheel well liner support bracket.  
See Photos D and E.

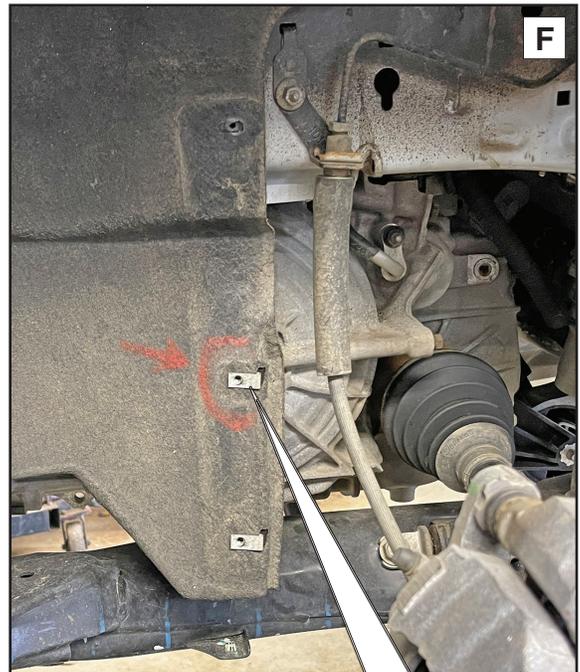
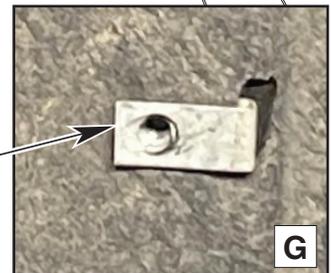
Screw  
Clip

4. Remove and discard screw clip shown in  
Photos F and G.

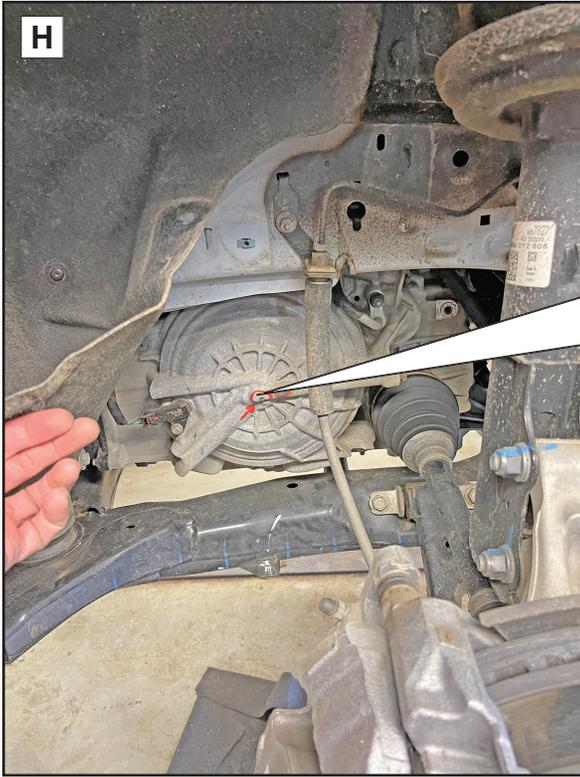
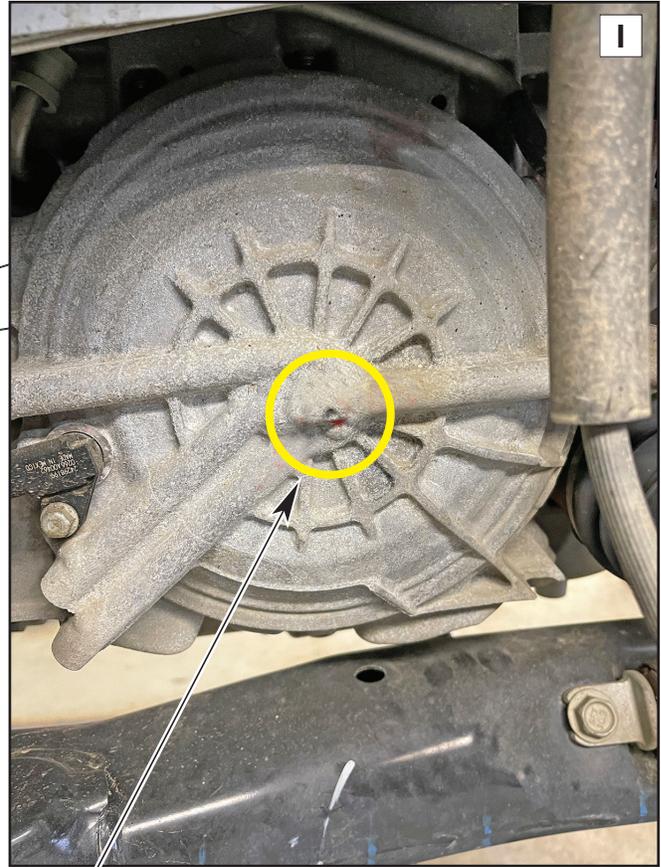
Inspect Here

5. Lift wheel well liner and inspect transmission housing for a leak. See Photos H and I.

If no leak is present proceed to Step 6.

If a leak is present: Create a case, upload photos, and contact BraunAbility technical support for further action.
