21508 JANUARY, 2022

SAFETY RECALL

ENGINE CONTROL MODULE (ECM) on certain 2020, 2021 and 2022 CE commercial bus models built 05/28/2019 thru 01/06/2022 with PSI 8.8L

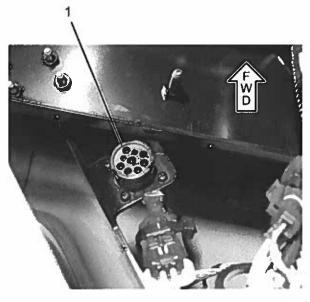
Figure 3. Data Link Connector (DLC) - Under Dash

1. DLC

11. Locate DLC (Figure 3, Item 1) under vehicle dash.

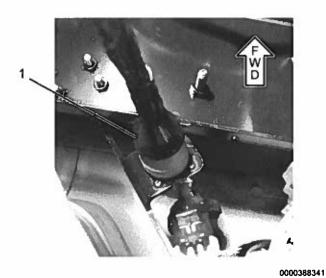
Figure 4. Powerlink Programming Cable – Under Dash

1. Connector

12. Connect 6-pin connector of programming cable (Figure 4, Item 1) to DLC.

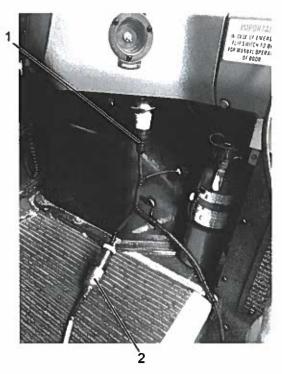
Figure 5. Powerlink Programming Cable - USB Interface

- 1. Connector
- 2. Laptop / USB interface connector

- 13. Connect programming cable (Figure 5, Item 1) to laptop / USB interface connector (Figure 5, Item 2).
- 14. Turn vehicle ignition to Key ON, Engine OFF.
