December 2021

Safety Recall Y73 / NHTSA 21V-842 Rear Spoiler

2021 (WD) Dodge Durango

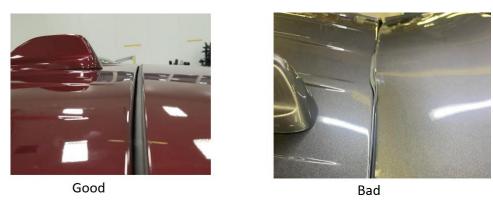
Figure 6 – Lip Seal Clearance Inspection

5. With the help of an assistant, open the liftgate while looking cross-car to ensure the spoiler seal does not hang up on the roof. Close the gate while making the same inspection. Repeat several times, while inspecting from both sides of the vehicle. A slight brush condition is acceptable. If the seal gets hung up, the upper spoiler must be replaced (Figure 6).

NOTE: If any one of the five inspection criteria above do not meet requirements, the rear spoiler must be replaced. If all five inspection criteria are met, the recall can be marked complete and the vehicle returned to the customer.
