Revision 2 February 2023

Dealer Service Instructions for:

Safety Recall Y73 / NHTSA 21V-842

Rear Spoiler

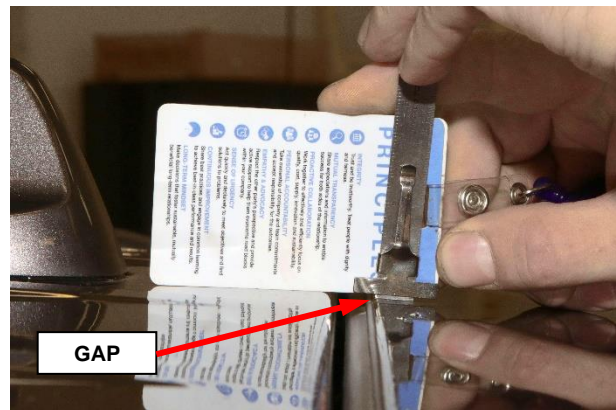
Figure 2 – Flushness of Spoiler to Roof

2. Rest a small straight edge (like to driver license or credit card) on the roof and check for flushness of the liftgate. Check at the center (behind the antennae), and at each end. The spoiler must not be more than 1mm over flush to the body. If it is, the upper spoiler must be replaced (Figure 2).

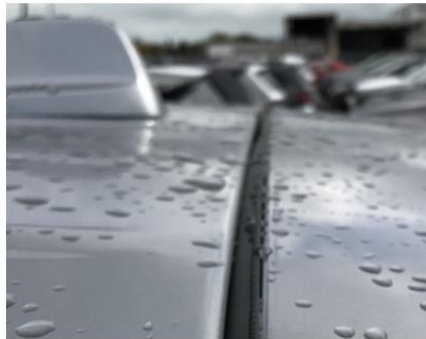
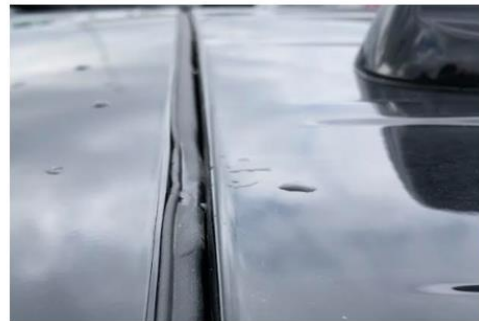
Figure 5 – Lip Seal Inspection

4. Visually inspect the lip seal. The seal must be sitting tight to the spoiler and not catching on the roof. The seal must not be distorted. If the seal does not pass inspection, the upper spoiler must be replaced (Figure 5).

Good

Bad

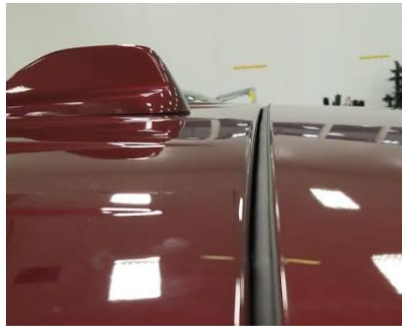
Figure 6 – Lip Seal Clearance Inspection

5. With the help of an assistant, open the liftgate while looking cross-car to ensure the spoiler seal does not hang up on the roof. Close the gate while making the same inspection. Repeat several times, while inspecting from both sides of the vehicle. A slight brush condition is acceptable. If the seal gets hung up, the upper spoiler must be replaced (Figure 6).

Good

Bad
