Revised February 2022

# Safety Recall Y73 / NHTSA 21V-842

## Rear Spoiler

#### 2021 (WD) Dodge Durango

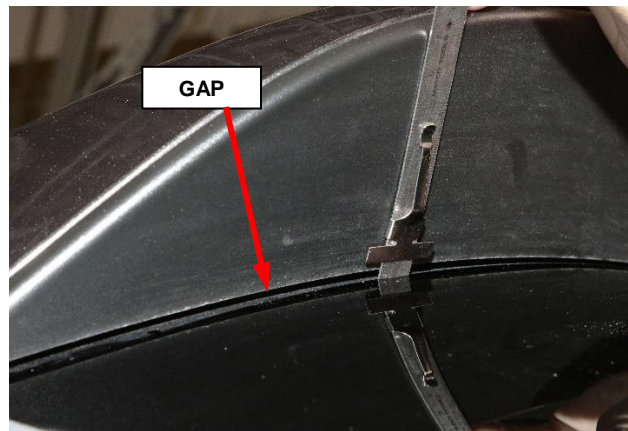
Figure 1 – Gap to Glass Inspection

1. Grasp the rear spoiler with one hand and gently push to feel for loose fasteners. After feeling for looseness, release the spoiler, and check the gap between the spoiler and the hatch glass on each side of the spoiler in line with the roof rack. If the gap is greater than 5mm, the upper spoiler must be replaced (Figure 1).

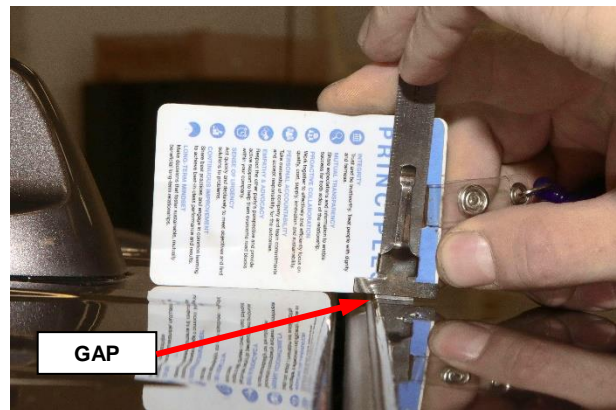
Figure 2 – Flushness of Spoiler to Roof

2. Rest a small straight edge (like to driver license or credit card) on the roof and check for flushness of the liftgate. Check at the center (behind the antennae), and at each end. The spoiler must not be more than 1mm over flush to the body. If it is, the upper spoiler must be replaced (Figure 2).

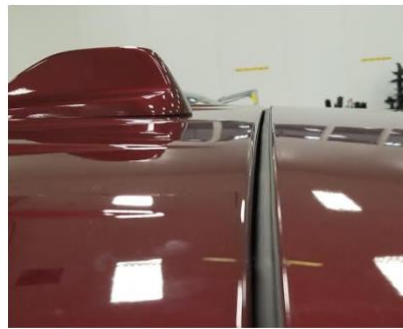
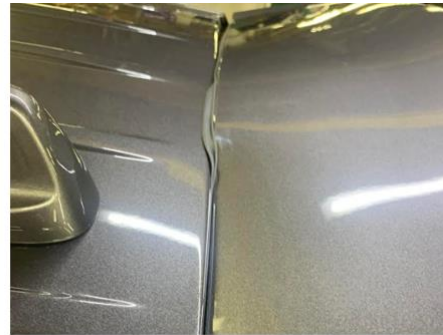
**Figure 6 – Lip Seal Clearance Inspection**

5. With the help of an assistant, open the liftgate while looking cross-car to ensure the spoiler seal does not hang up on the roof. Close the gate while making the same inspection. Repeat several times, while inspecting from both sides of the vehicle. A slight brush condition is acceptable. If the seal gets hung up, the upper spoiler must be replaced (Figure 6).

Good

Bad
