Dealer Service Instructions for:

Safety Recall Y73 / NHTSA 21V-842

Rear Spoiler

2021 (WD) Dodge Durango

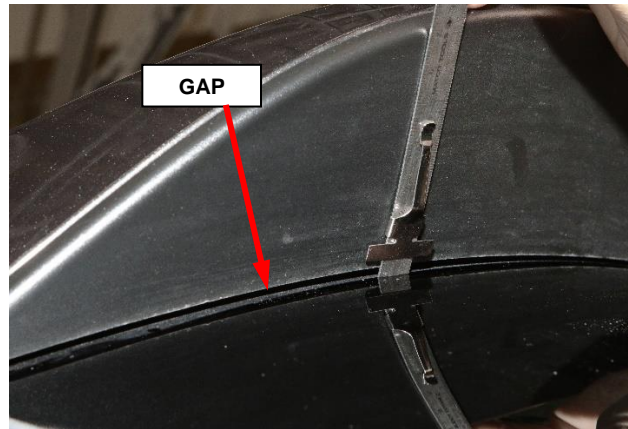
**Figure 1 – Gap to Glass Inspection**

1. Grasp the rear spoiler with one hand and gently push to feel for loose fasteners. After feeling for looseness, release the spoiler, and check the gap between the spoiler and the hatch glass on each side of the spoiler in line with the roof rack. If the gap is greater than 5mm, the upper spoiler must be replaced (Figure 1).

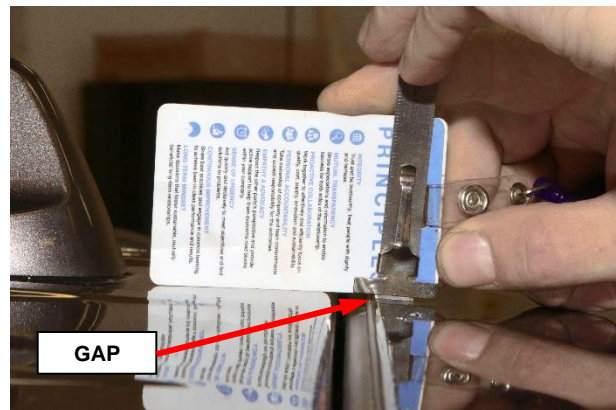
**Figure 2 – Flushness of Spoiler to Roof**

2. Rest a small straight edge (like to driver license or credit card) on the roof and check for flushness of the liftgate. Check at the center (behind the antennae), and at each end. The spoiler must not be more than 1mm over flush to the body. If it is, the upper spoiler must be replaced (Figure 2).

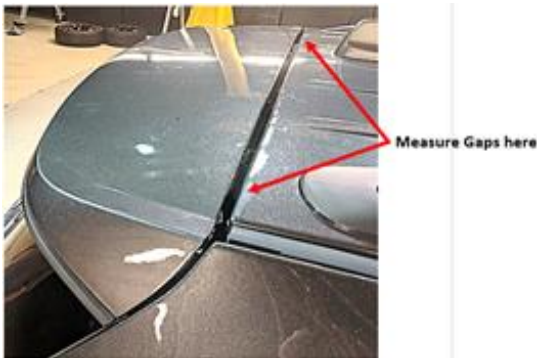
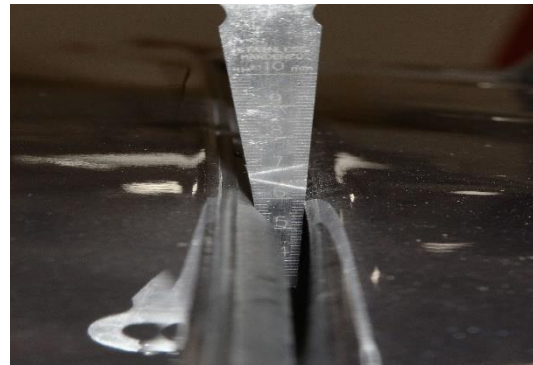
Figure 3 – Gap from Spoiler to Roof

3. Measure the gap between the spoiler and roof on the right and left ends. This gap must be 6mm or greater. If not, the upper spoiler must be replaced (Figures 3 and 4).

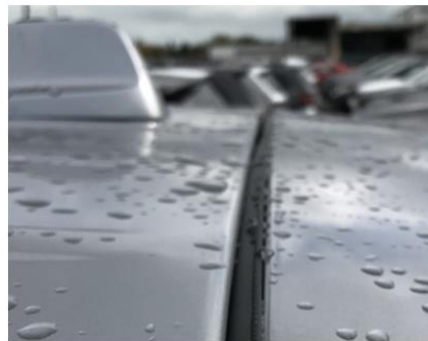
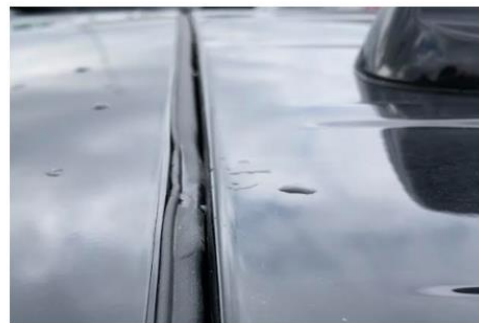
Figure 5 – Lip Seal Inspection

4. Visually inspect the lip seal. The seal must be sitting tight to the spoiler and not catching on the roof. The seal must not be distorted. If the seal does not pass inspection, the upper spoiler must be replaced (Figure 5).

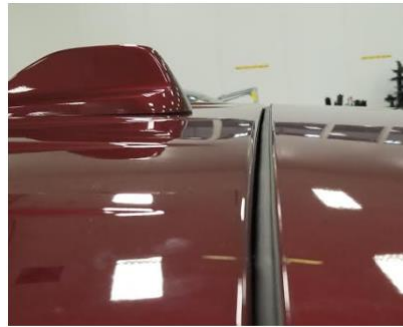
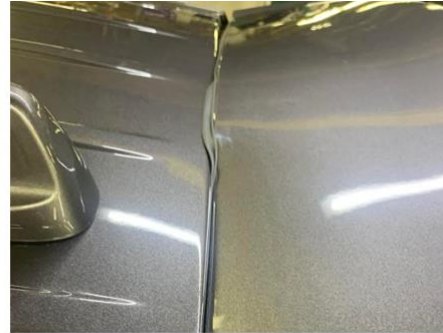
Figure 6 – Lip Seal Clearance Inspection

5. With the help of an assistant, open the liftgate while looking cross-car to ensure the spoiler seal does not hang up on the roof. Close the gate while making the same inspection. Repeat several times, while inspecting from both sides of the vehicle. A slight brush condition is acceptable. If the seal gets hung up, the upper spoiler must be replaced (Figure 6).
