SAFETY RECALL

Mack Trucks Inc. Greensboro, NC USA

Date 11.2021 Number SC0432

ZF Power Steering Pump Replacement GR and LR

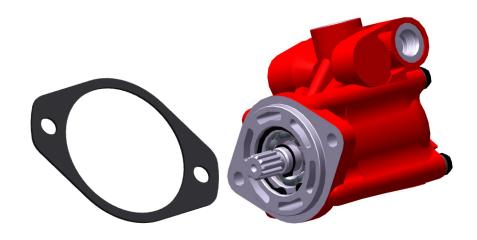
Diesel Engine mounting gasket shown below

- 1. Secure vehicle for service.
- 2. Remove and replace power steering pump referencing IMPACT operation ID 6453-03-02-01.
- 3. Release vehicle to service.
