SIB 11 10 21

2022-10-26

RECALL 21V-907: EXHAUST GAS RECIRCULATION (EGR) COOLER – N57T LOW TEMPERATURE

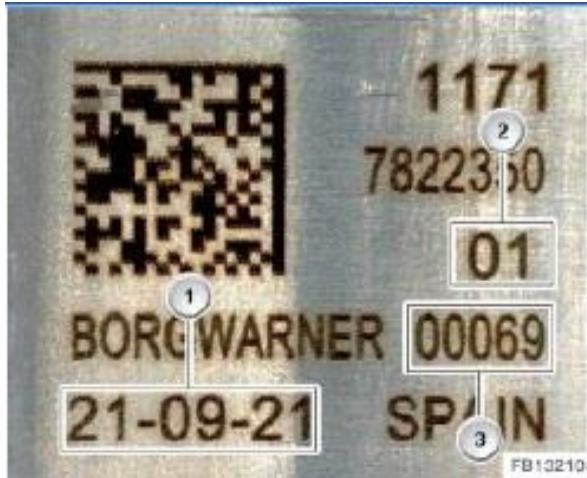
Record or take a photo of the following numbers on the new EGR cooler (1,2 and 3). These numbers will be required later to register the new cooler in ISTA.

1. Production date [YY-MM-DD]
2. Revision index
3. Serial number

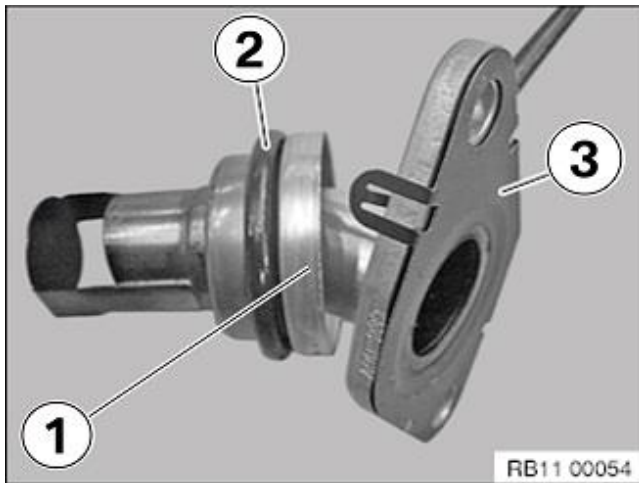
- When the old EGR cooler is removed:

- Remove the EGR pipe from the intake venturi pipe (replace O-ring (2) and gasket (3)).

- Inspect and clean (if needed) the EGR pipe. Wear protective equipment (eyes and hands) and clean out the excessive carbon using a degreasing agent and a brush (suitable brushes can be found in wheel brush kit 83 19 2 298 237).
- Reinstall the EGR pipe with new gasket and O-ring before installing the new EGR cooler.

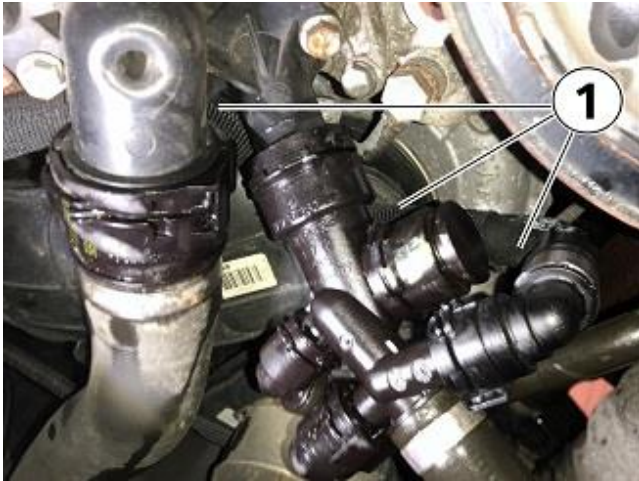
- NOTE: The new coolant line PN 11 14 7 827 410 is routed in a different location than the original line (1)

- Install the new EGR cooler following the repair instructions.
- Replace the vacuum hose PN 11 65 8 595 650 (enough hose for two repairs) from the changeover valve to the bypass flap on the cooler (measure the new hose and cut according to the old hose)
- The acoustic cover will be replaced with PN 11 14 8 490 569 (if an acoustic covered was installed)
