SIB 11 11 21

RECALL 21V-907: EXHAUST GAS RECIRCULATION (EGR) COOLER – N47T LOW TEMPERATURE

E-Series	Model Description	Production Date	Affected Engine Type
F25	X3 Sports Activity Vehicle	February 17, 2014 – December 21, 2016	N47T

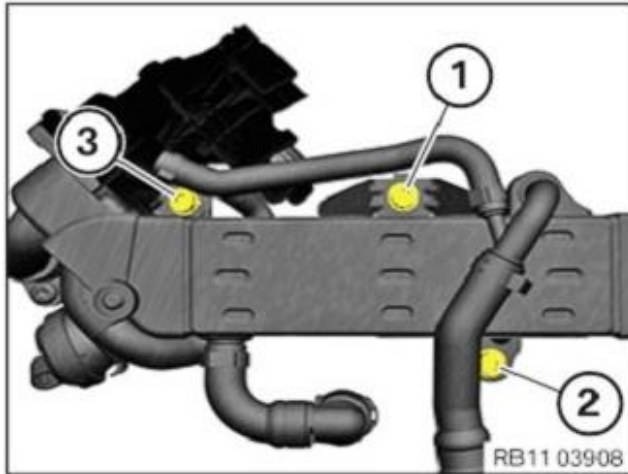
- Inspect highlighted screws before reusing.
