SIB 11 10 21

2024-07-12

RECALL 21V-907: EXHAUST GAS RECIRCULATION (EGR) COOLER – N57T LOW TEMPERATURE

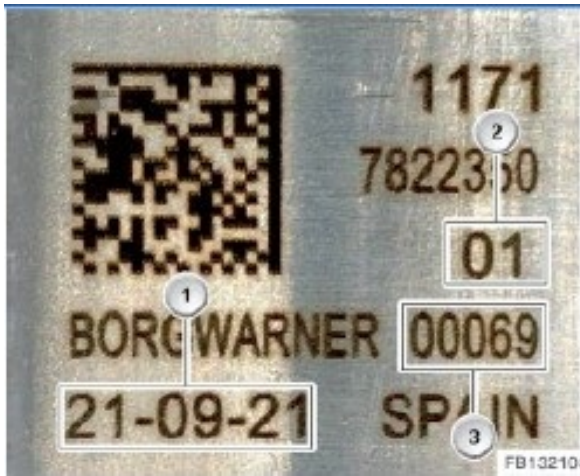
Hint: Record or take a photo of the following numbers on the new EGR cooler before installation (1, 2 and 3). These numbers will be required later to register the new cooler in ISTA.

1. Production date [YY-MM-DD]
2. Revision index
3. Serial number

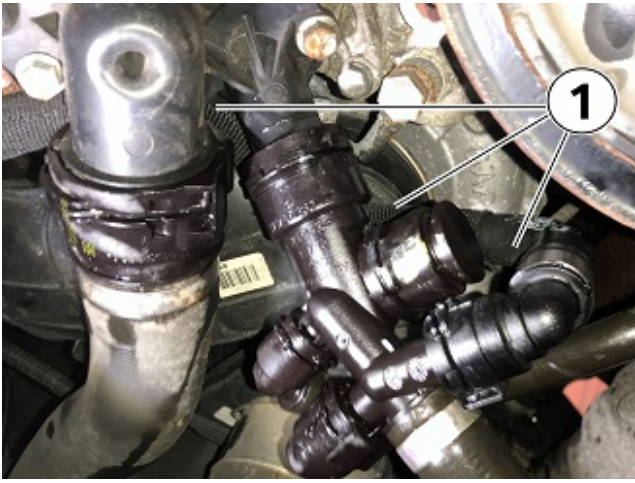
- NOTE: The new coolant line PN 11 14 7 827 410 is routed in a different location than the original line (1)

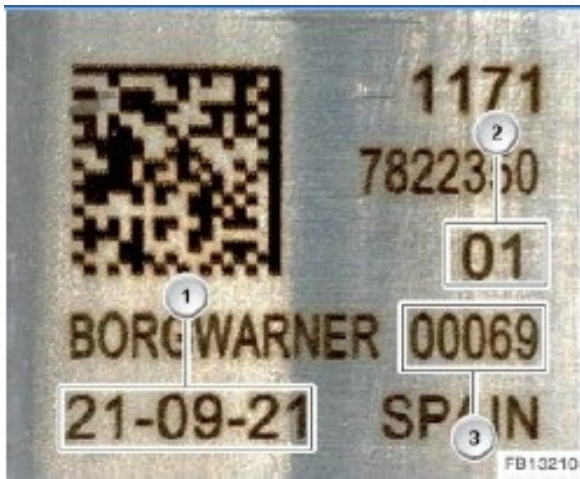
Hint: Record or take a photo of the following numbers on the new EGR cooler before installation (1, 2 and 3). These numbers will be required later to register the new cooler in ISTA.

1. Production date [YY-MM-DD]
2. Revision index
3. Serial number

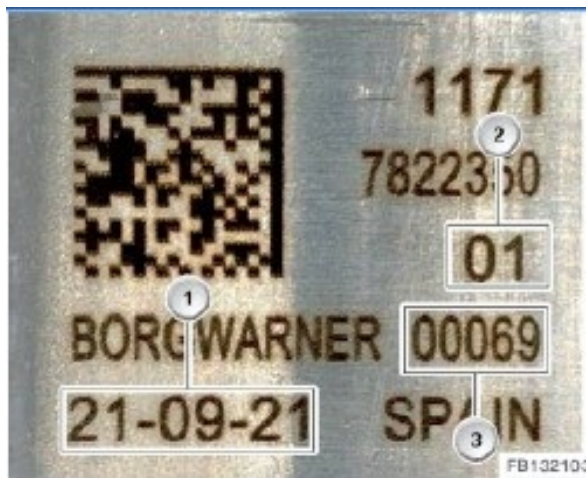
Hint: Record or take a photo of the following numbers on the new EGR cooler before installation (1, 2 and 3). These numbers will be required later to register the new cooler in ISTA.

1. Production date [YY-MM-DD]
2. Revision index
3. Serial number

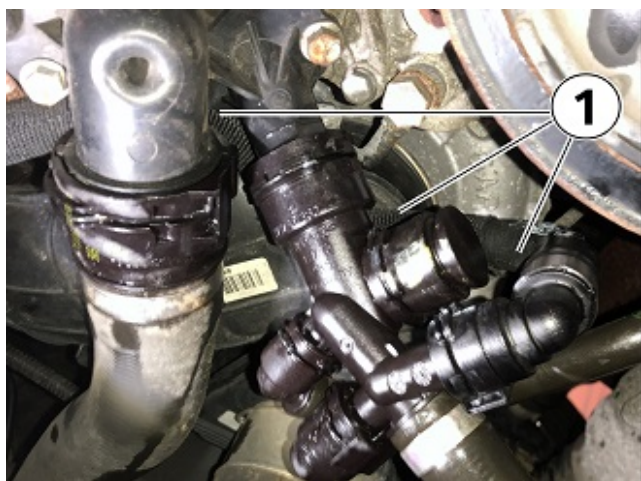
- NOTE: The new coolant line P/N 11 14 7 827 410 is routed in a different location than the original line (1)

- Replace the coolant pipe from the Auxiliary EGR cooler to the coolant pump distribution block (1)

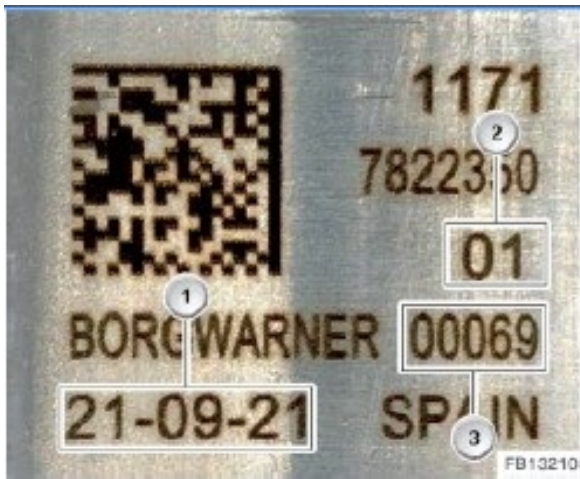
Hint: Record or take a photo of the following numbers on the new EGR cooler before installation (1, 2 and 3). These numbers will be required later to register the new cooler in ISTA.

1. Production date [YY-MM-DD]
2. Revision index
3. Serial number
