SIB 11 08 21

2025-03-07

RECALL 21V-907: EXHAUST GAS RECIRCULATION (EGR) COOLER – N57T HIGH TEMPERATURE

This Service Information Bulletin (Revision 8) replaces SI B11 08 21 **dated January 2025**.

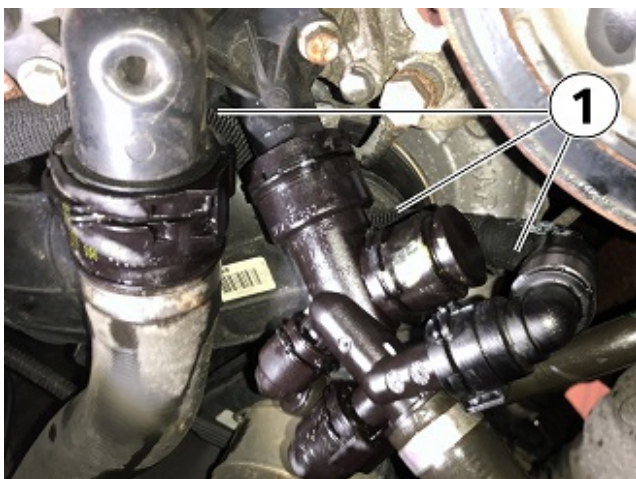
- NOTE: The new coolant line P/N 11 14 7 827 410 is routed in a different location than the original line (1)

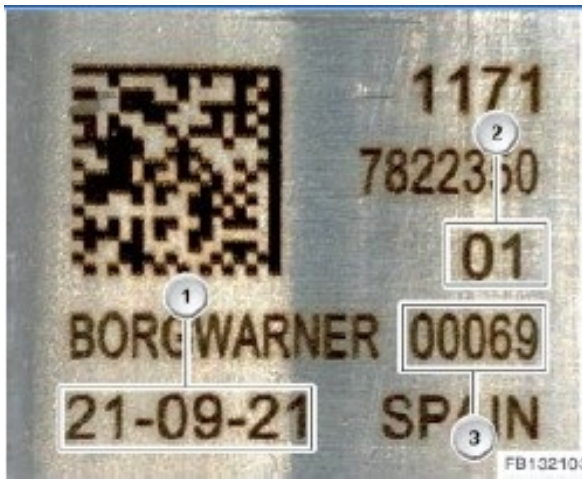
Hint: Record or take a photo of the following numbers on the new EGR cooler before installation (1, 2 and 3). These numbers will be required later to register the new cooler in ISTA.

1. Production date [YY-MM-DD]
2. Revision index
3. Serial number

Follow **Repair Instruction 00 71 203 Replacing low-temperature exhaust gas recirculation cooler**. This repair instruction is specific to replacing the cooler during a technical campaign (recall).

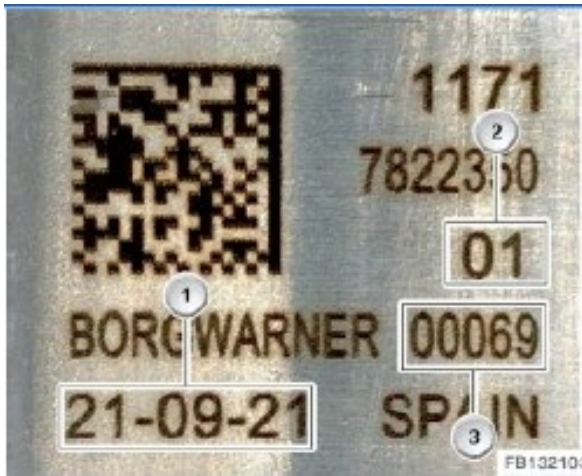
Hint: Record or take a photo of the following numbers on the new EGR cooler before installation (1, 2 and 3). These numbers will be required later to register the new cooler in ISTA.

1. Production date [YY-MM-DD]
2. Revision index
3. Serial number

Follow **Repair Instruction 00 71 277 Replacing low-temperature exhaust gas recirculation cooler**. This repair instruction is specific to replacing the cooler during a technical campaign (recall).

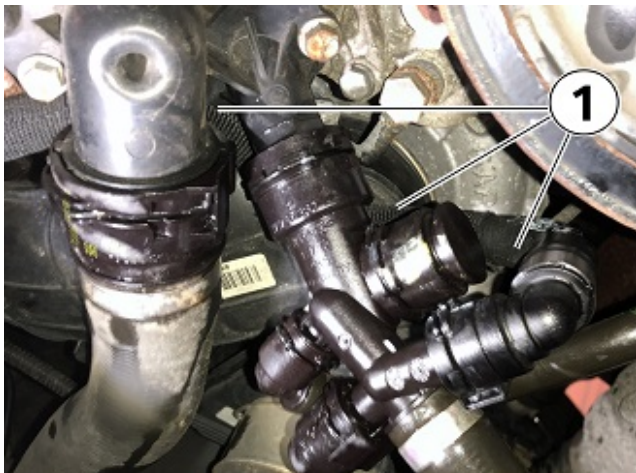
- NOTE: The new coolant line PN 11 14 7 827 410 is routed in a different location than the original line (1)

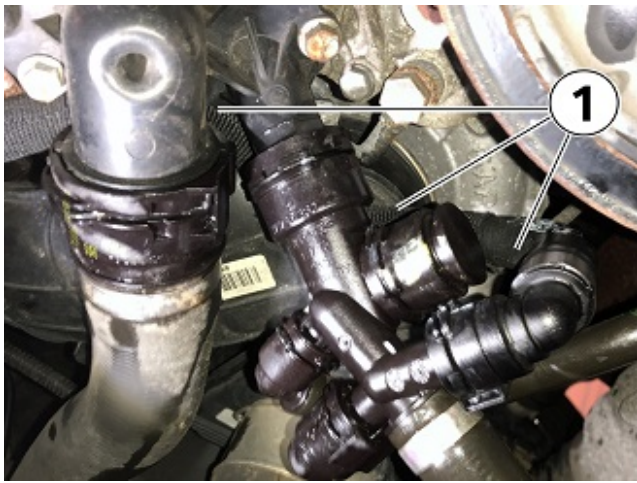
- NOTE: The new coolant line PN 11 14 7 827 410 is routed in a different location than the original line (1)

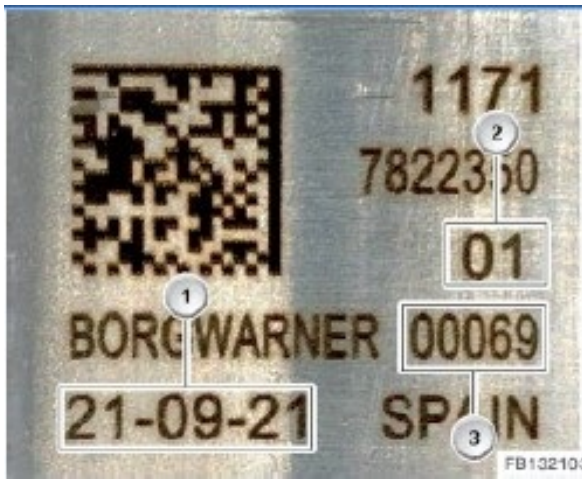
Hint: Record or take a photo of the following numbers on the new EGR cooler before installation (1, 2 and 3). These numbers will be required later to register the new cooler in ISTA.

1. Production date [YY-MM-DD]
2. Revision index
3. Serial number

Follow **Repair Instruction 00 71 277 Replacing low-temperature exhaust gas recirculation cooler**. This repair instruction is specific to replacing the cooler during a technical campaign (recall).
