SIB 11 10 21

2024-01-04

RECALL 21V-907: EXHAUST GAS RECIRCULATION (EGR) COOLER – N57T LOW TEMPERATURE

This Service Information Bulletin (Revision 4) replaces SI B11 10 21 **dated October 2022**.

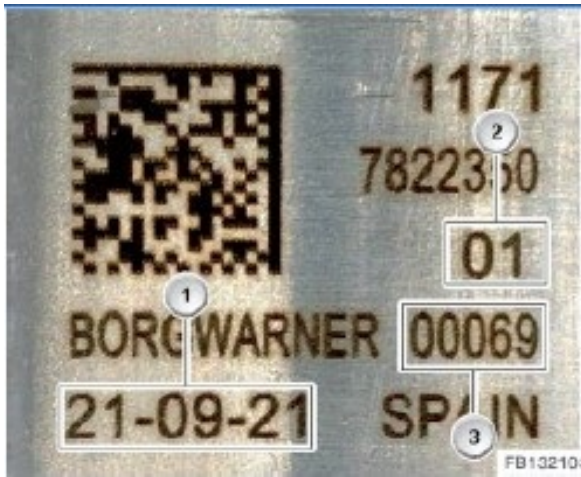
Hint: Record or take a photo of the following numbers on the new EGR cooler before installation (1, 2 and 3). These numbers will be required later to register the new cooler in ISTA.

1. Production date [YY-MM-DD]
2. Revision index
3. Serial number

Follow **Repair Instruction 00 71 277 Replacing low-temperature exhaust gas recirculation cooler**. This repair instruction is specific to replacing the cooler during a technical campaign (recall).

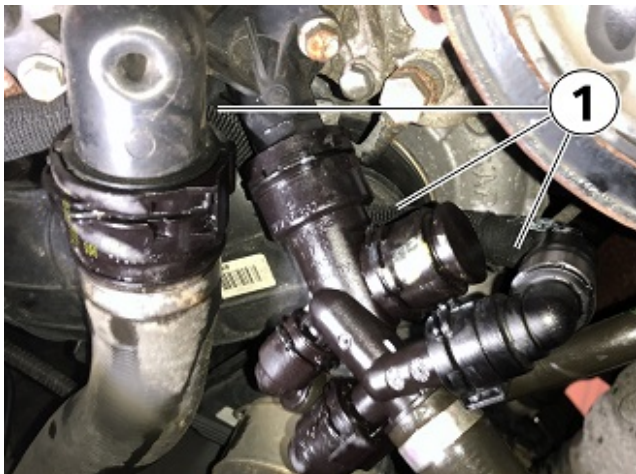
- **NOTE:** The new coolant line PN 11 14 7 827 410 is routed in a different location than the original line (1)

- Replace the coolant pipe from the Auxiliary EGR cooler to the coolant pump distribution block (1)

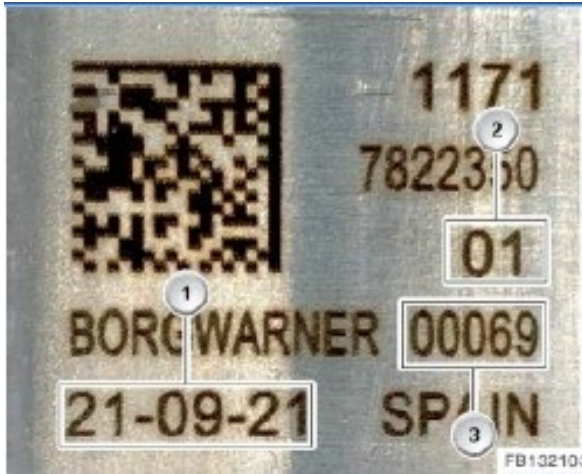
Hint: Record or take a photo of the following numbers on the new EGR cooler before installation (1, 2 and 3). These numbers will be required later to register the new cooler in ISTA.

1. Production date [YY-MM-DD]
2. Revision index
3. Serial number

Follow **Repair Instruction 00 71 277 Replacing low-temperature exhaust gas recirculation cooler**. This repair instruction is specific to replacing the cooler during a technical campaign (recall).

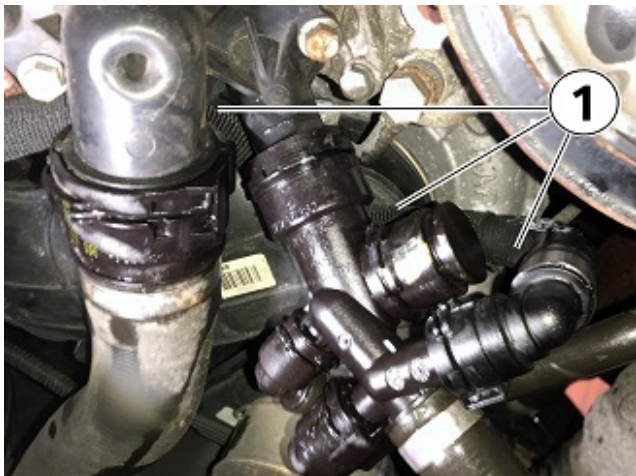
- NOTE: The new coolant line P/N 11 14 7 827 410 is routed in a different location than the original line (1)

- Replace the coolant pipe from the Auxiliary EGR cooler to the coolant pump distribution block (1)

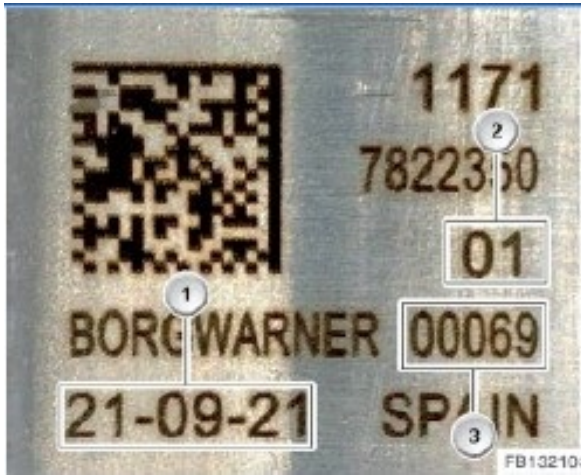
Hint: Record or take a photo of the following numbers on the new EGR cooler before installation (1, 2 and 3). These numbers will be required later to register the new cooler in ISTA.

1. Production date [YY-MM-DD]
2. Revision index
3. Serial number

Follow **Repair Instruction 00 71 277 Replacing low-temperature exhaust gas recirculation cooler**. This repair instruction is specific to replacing the cooler during a technical campaign (recall).
