SIB 11 08 21

2025-01-22

RECALL 21V-907: EXHAUST GAS RECIRCULATION (EGR) COOLER – N57T HIGH TEMPERATURE

This Service Information Bulletin (Revision 7) replaces SI B11 08 21 **dated July 2024**.

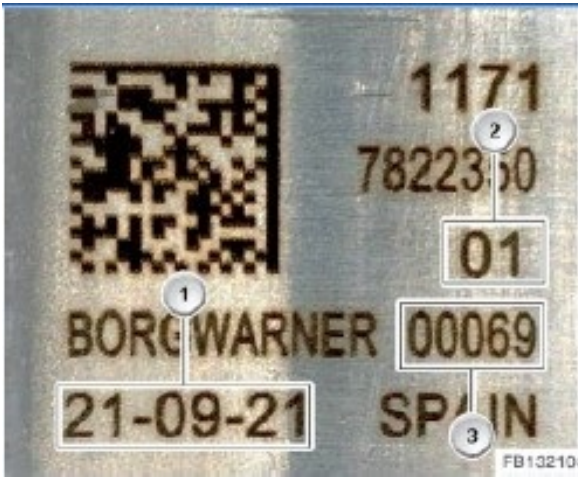
Hint: Record or take a photo of the following numbers on the new EGR cooler before installation (1, 2 and 3). These numbers will be required later to register the new cooler in ISTA.

1. Production date [YY-MM-DD]
2. Revision index
3. Serial number

Follow **Repair Instruction 00 71 277 Replacing high-temperature exhaust gas recirculation cooler**. This repair instruction is specific to replacing the cooler during a technical campaign (recall).

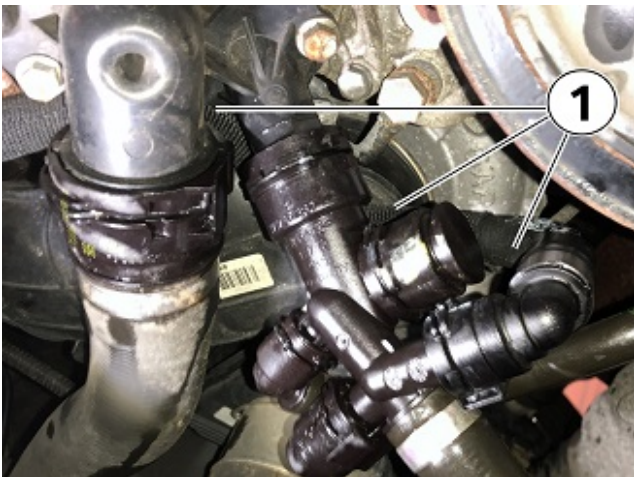
- NOTE: The new coolant line P/N 11 14 7 827 410 is routed in a different location than the original line (1)

- Replace the coolant pipe from the Auxiliary EGR cooler to the coolant pump distribution block (1)

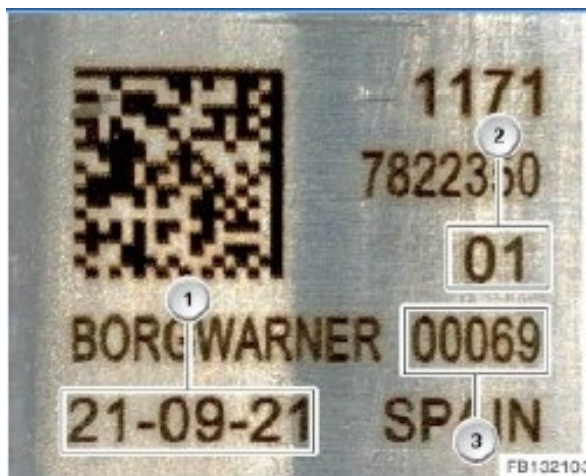
Hint: Record or take a photo of the following numbers on the new EGR cooler before installation (1, 2 and 3). These numbers will be required later to register the new cooler in ISTA.

1. Production date [YY-MM-DD]
2. Revision index
3. Serial number

Follow **Repair Instruction 00 71 277 Replacing low-temperature exhaust gas recirculation cooler**. This repair instruction is specific to replacing the cooler during a technical campaign (recall).

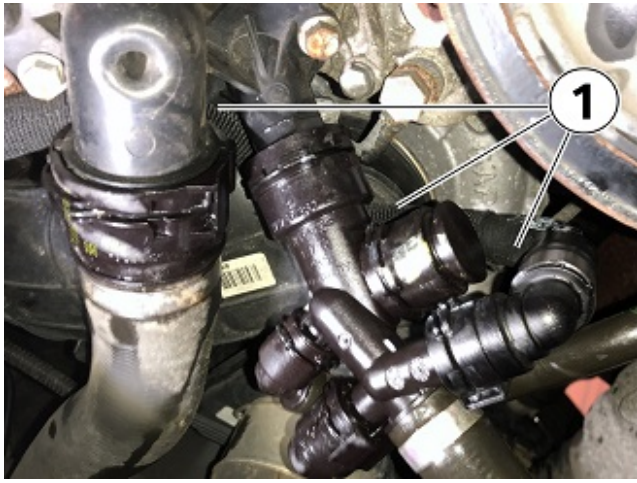
- NOTE: The new coolant line PN 11 14 7 827 410 is routed in a different location than the original line (1)
