SIB 11 11 21

## RECALL 21V-907: EXHAUST GAS RECIRCULATION (EGR) COOLER – N47T LOW TEMPERATURE

### PROCEDURE 1: REPLACE THE EGR COOLER

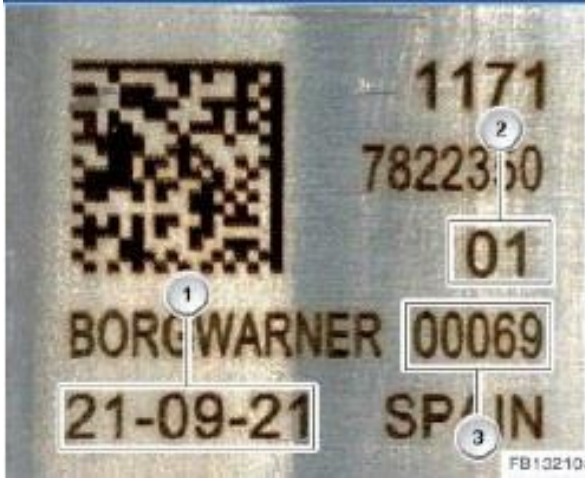
Record or take a photo of the following numbers on the new EGR cooler (1, 2 and 3). These numbers will be required later to register the new cooler in ISTA.

1. Production date [YY-MM-DD]
2. Revision index
3. Serial number

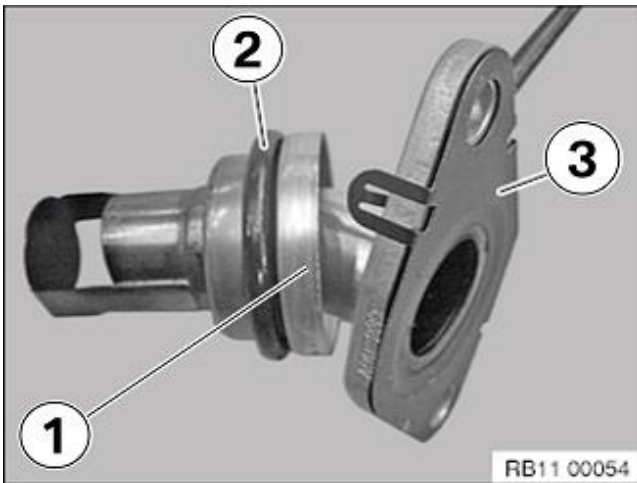
- When the old EGR cooler is removed:

- Remove the EGR pipe from the intake venturi pipe (replace O-ring (2) and gasket (3)).

- Inspect and clean (if needed) the EGR pipe. Wear protective equipment (eyes and hands) and clean out the excessive carbon using a degreasing agent and a brush (suitable brushes can be found in wheel brush kit 83 19 2 298 237).
- Reinstall the EGR pipe with new gasket and O-ring before installing the new EGR cooler.
- Install the new EGR cooler following the repair instructions.
- Replace the coolant line with temperature sensor 11 53 7 827 841
