SIB 11 09 21

RECALL 21V-907: EXHAUST GAS RECIRCULATION (EGR) COOLER – N47T HIGH TEMPERATURE

This Service Information Bulletin (Revision 5) replaces SI B11 09 21 **dated September 2022**.

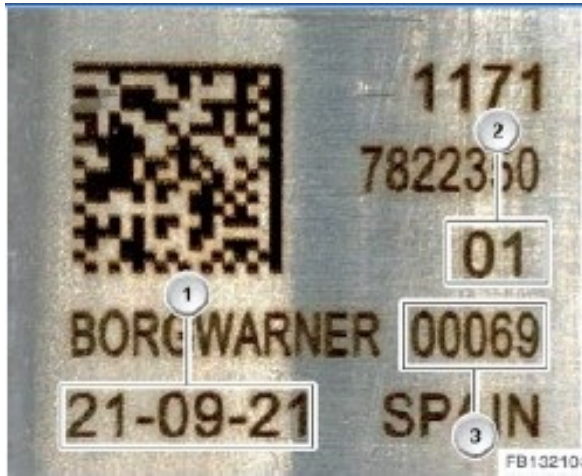
Hint: Record or take a photo of the following numbers on the new EGR cooler before installation (1, 2 and 3). These numbers will be required later to register the new cooler in ISTA.

1. Production date [YY-MM-DD]
2. Revision index
3. Serial number
