AMC3 - Reworking Threaded Joints on the Rear Axle (Stop Use/Recall Campaign)

Model Line: **Taycan (Y1A)**

Model Year: **As of 2020 up to 2021**

Concerns: **Threaded connections on upper control arms of the rear axle**

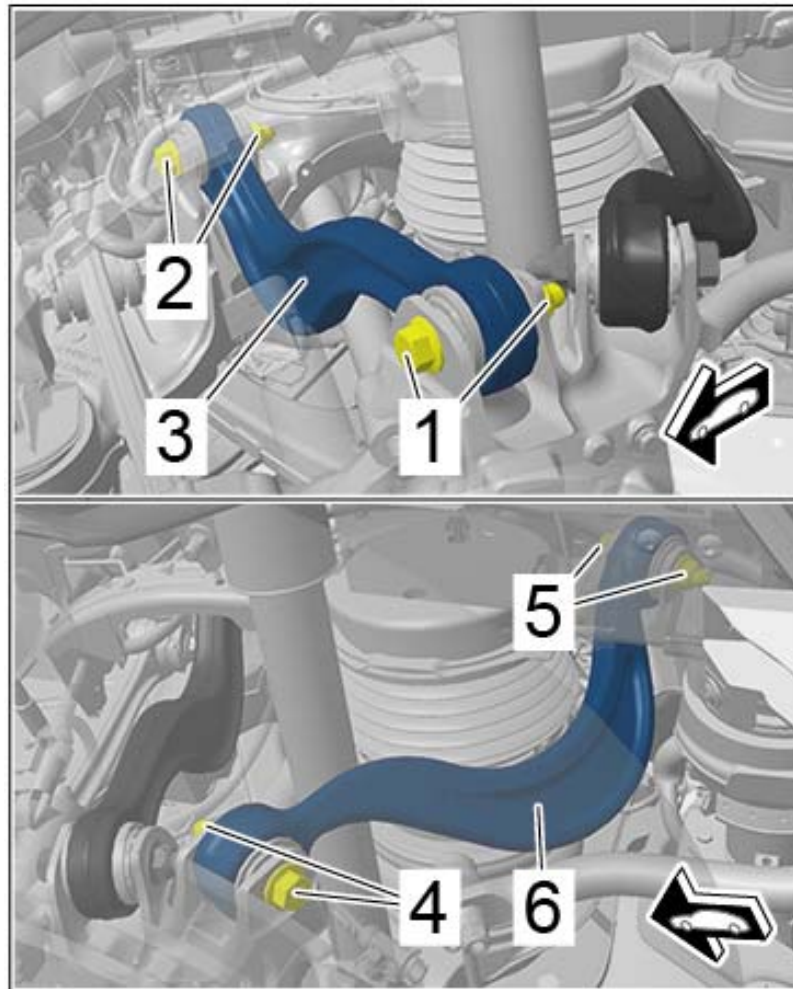
Control arm on rear axle (shown on left)

After removing the relevant bolts, perform a **visual inspection** for **signs of damage caused by driving** in the area around the relevant screw points.

- 5.1 Replace the following threaded connections ⇒ *Control arm on rear axle (shown on left)* - **1** **und 2** - on the front upper control arm ⇒ *Control arm on rear axle (shown on left)* - **3** - on the rear axle at the left and right.

- 5.2 Replace the following threaded connections ⇒ *Control arm on rear axle (shown on left)* -**4** and **5**- on the rear upper control arm ⇒ *Control arm on rear axle (shown on left)* -**6**- on the rear axle at the left and right.
