Safety Recall Code: 42L2

Suspension Strut

January 28, 2022

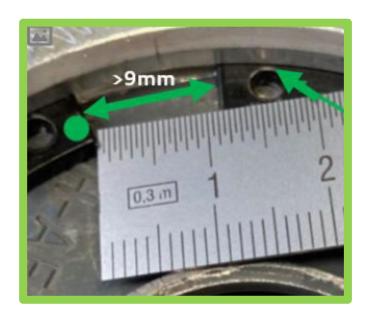
- If the measured distance of the circlip is greater than 9 mm and if the two holes on the circlip <second green arrow> are in direct contact with the flange:
 - The strut is OK.
 - If both struts are OK, reinstall the plenum chamber cover in the reverse order of removal and Proceed to Section D.

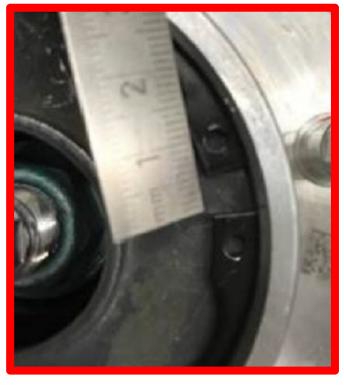
- If the measured distance of the circlip is less than 9 mm and/or if the two holes on the circlip are not in direct contact with the flange:
 - The affected strut must be replaced.
 - Proceed to Section C.
