Safety Recall

Code: 90S9

Subject	Gateway Control Module																									
Release Date	March 08, 2023																									
REVISION SUMMARY	Added additional sealant part number																									
Affected Vehicles

Subject: Safety Recall 90S9 – Gateway Control Module

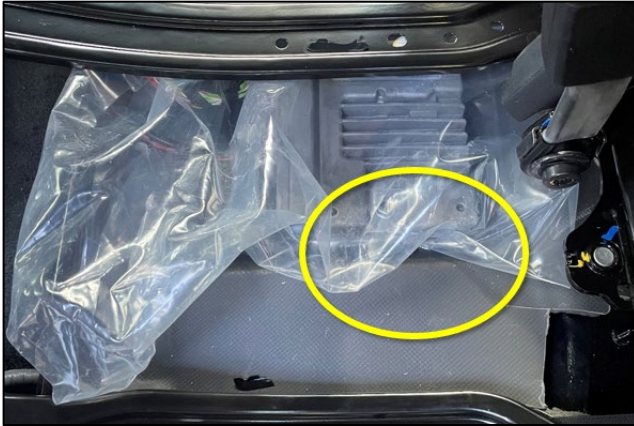
Ensure the cover is installed correctly. If the cover is folded under the gateway, it's possible to pinch the cover and create a puncture in the cover. Pay very close attention to how the cover is installed and also ensure the bolts are torqued correctly. Below are examples of covers that were not installed correctly, which can result in liquid entering the cover and damaging the gateway.

Cover folded under the gateway.

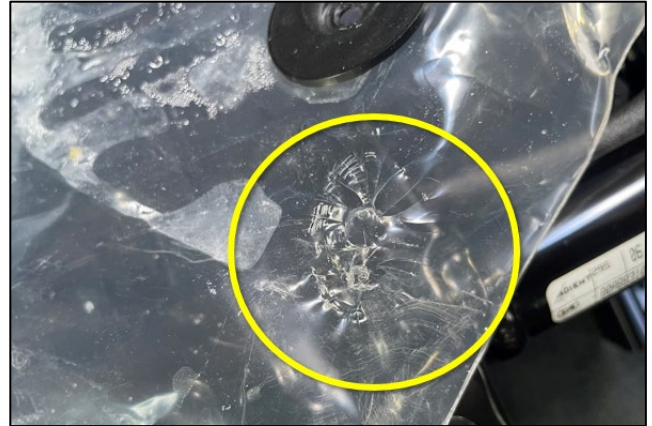
Cover pinched, resulting in puncture.

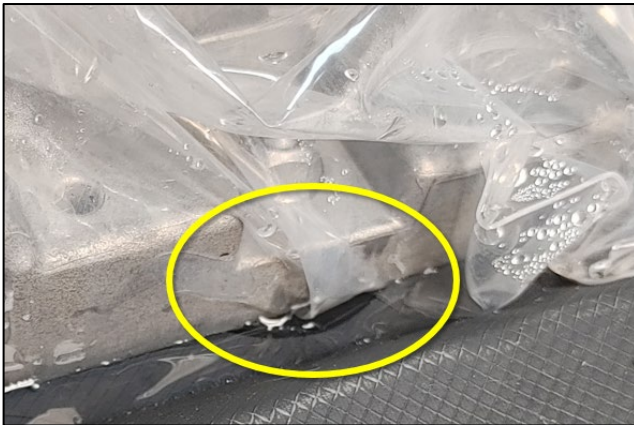
Cover folded under the gateway.

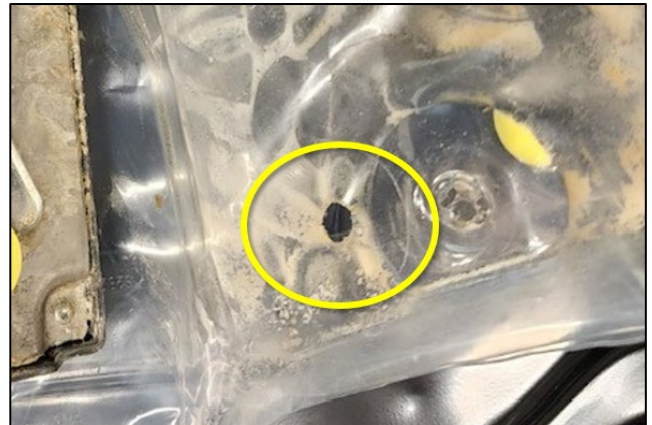
Cover pinched, resulting in puncture.

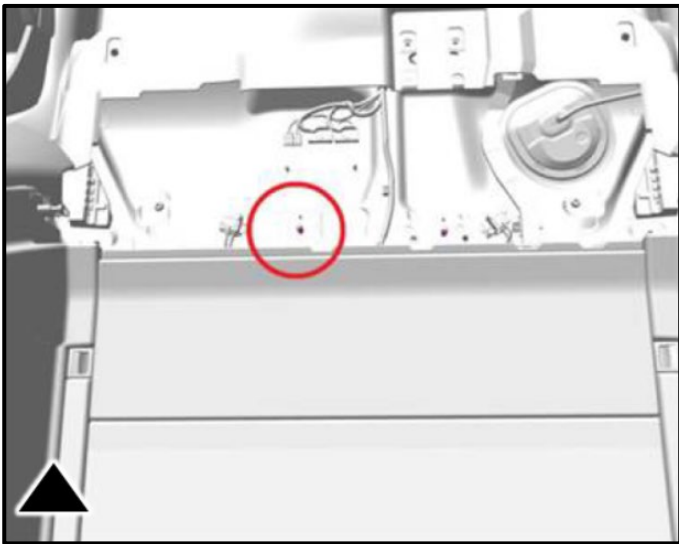
- The stud and area requiring sealant shown <circle>.

Prep area for sealant:
