**PRODUCT CAMPAIGN BULLETIN**

**APPLICABILITY:** 2020 MY Ascent

**NUMBER:** WRL-21R

**SUBJECT:** Front Axle Housings

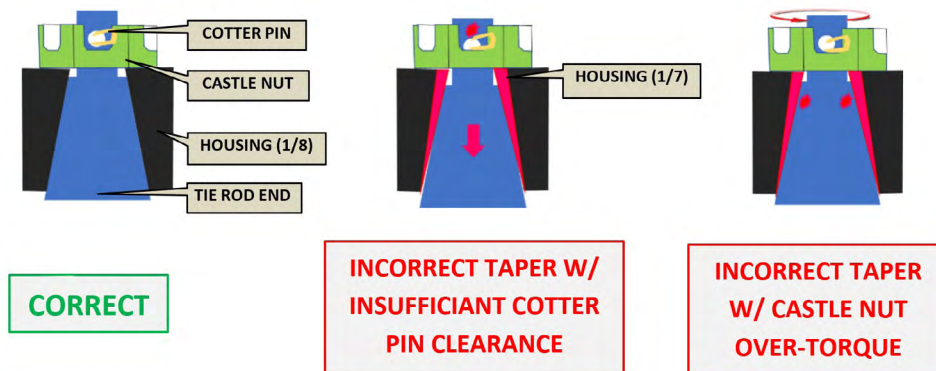
### Axle Housing/Tie rod End Mounting Description:

The affected vehicles may be equipped with front axle housings that may have been manufactured with improperly tapered tie rod mounting holes. Over time, this condition may cause the tie rod end to separate from the axle housing, increasing the risk of a crash.

For all potentially affected vehicles, Subaru retailers will replace left front and right front housings, tie rod ends, and all related hardware with new parts at no cost to the customer.

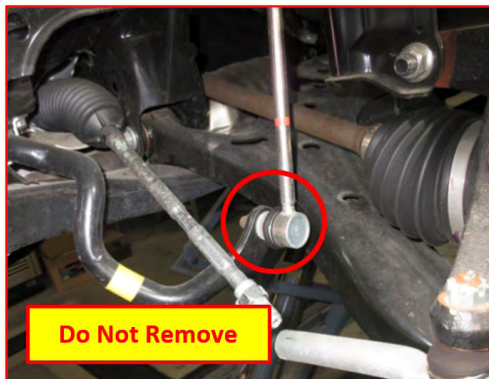
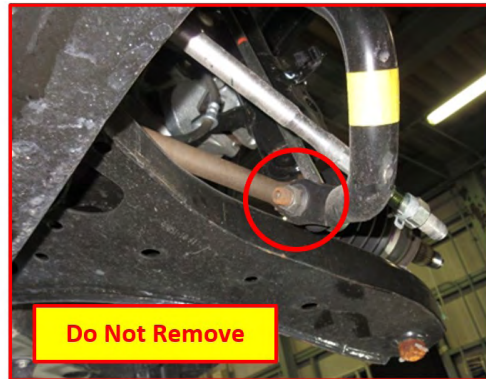
**Tip 1:** The stabilizer link mounting nut (902380003) **DOES NOT** require removal during this procedure. This nut is a one-time use only part and if removed it **MUST** be replaced with a new one. See the photos listed below for examples.

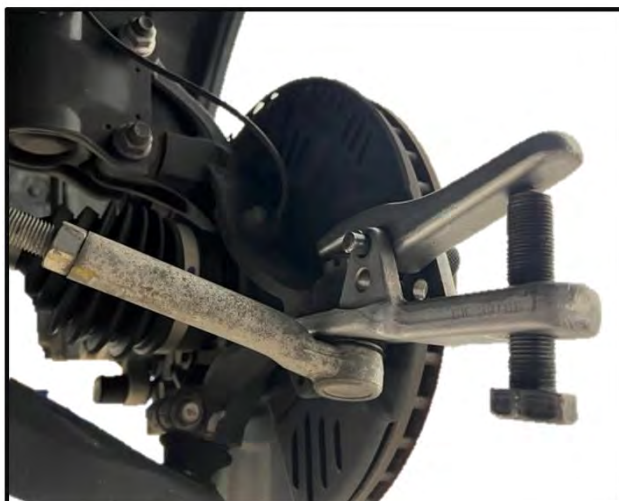
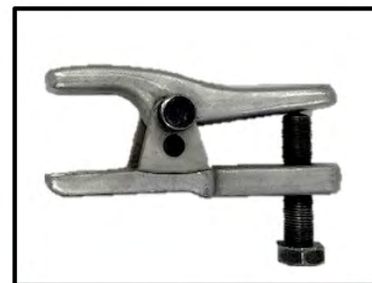
OTC Ball Joint Separator **16-6297**  
shown above is available through the  
Subaru Dealer Equipment website:  
[subaruretailersolutions.com](http://subaruretailersolutions.com)

**Tip 2:** Even with usage of a recommended ball joint separator tool (shown below), there can be difficulty separating the tie rod end from the axle housing. This is caused by possible deformation of housing/tie rod from exceeded torque limits during installation. **ALWAYS** use eye protection when attempting to apply this method. If there is difficulty found when removing/separating the tie rod end with the axle housing, follow the procedures outlined on the next page.
