**PRODUCT CAMPAIGN BULLETIN**

**APPLICABILITY:** 2020 MY Ascent

**NUMBER:** WRL-21

**SUBJECT:** Front Axle Housings

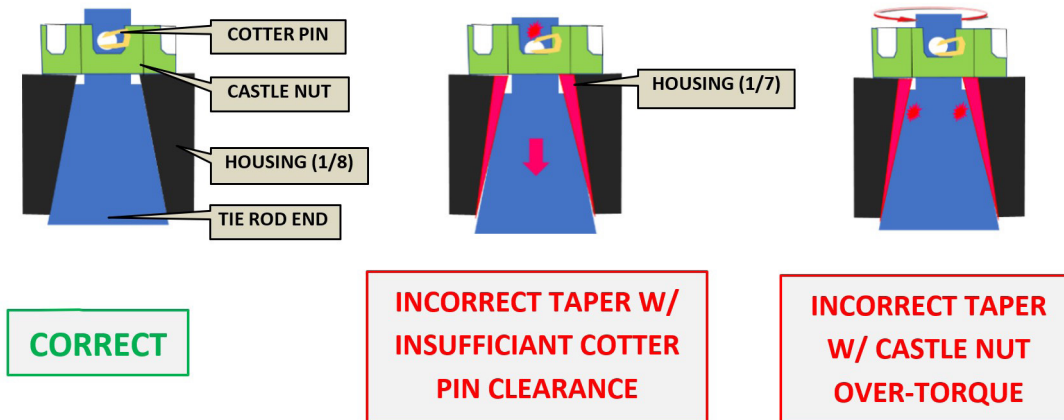
### Axle Housing/Tie rod End Mounting Description:

The affected vehicles may be equipped with front axle housings that may have been manufactured with improperly tapered tie rod mounting holes. Over time, this condition may cause the tie rod end to separate from the axle housing, increasing the risk of a crash.

For all potentially affected vehicles, Subaru retailers will replace left front and right front housings, tie rod ends, and all related hardware with new parts at no cost to the customer.

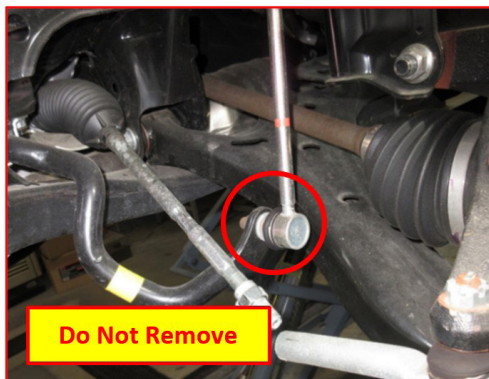
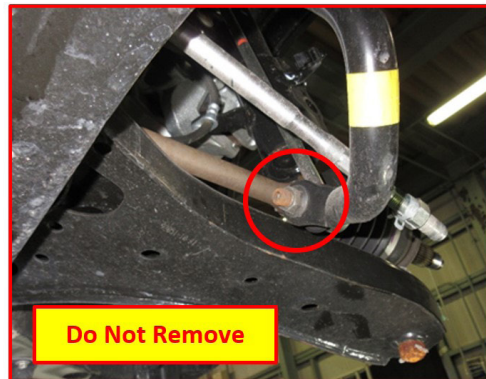
**Tip 1:** The stabilizer link mounting nut (902380003) **DOES NOT** require removal during this procedure. This nut is a one-time use only part and if removed it **MUST** be replaced with a new one. See the photos listed below for examples.

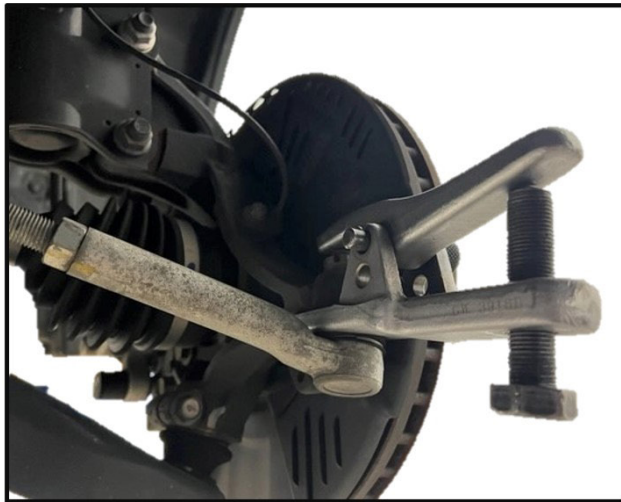
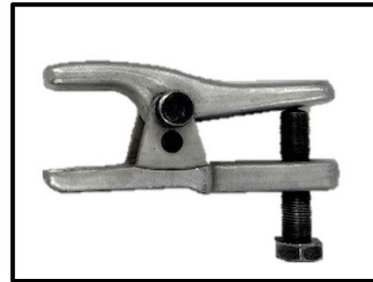
OTC Ball Joint Separator **16-6297** shown above is available through the Subaru Dealer Equipment website: [subaruretailersolutions.com](http://subaruretailersolutions.com)

**Tip 2:** Even with usage of a recommended ball joint separator tool (shown below), there can be difficulty separating the tie rod end from the axle housing. This is caused by possible deformation of housing/tie rod from exceeded torque limits during installation. **ALWAYS** use eye protection when attempting to apply this method. If there is difficulty found when removing/separating the tie rod end with the axle housing, follow the procedures outlined on the next page.
