PRODUCT CAMPAIGN BULLETIN

APPLICABILITY: 2019-20MY Ascent
 2021MY Legacy 2.4L (turbo models)
 2021MY Outback 2.4L (turbo models)
SUBJECT: CVT Chain Guide Breakage

NUMBER: WRK-21/22R

DATE: 07/05/22

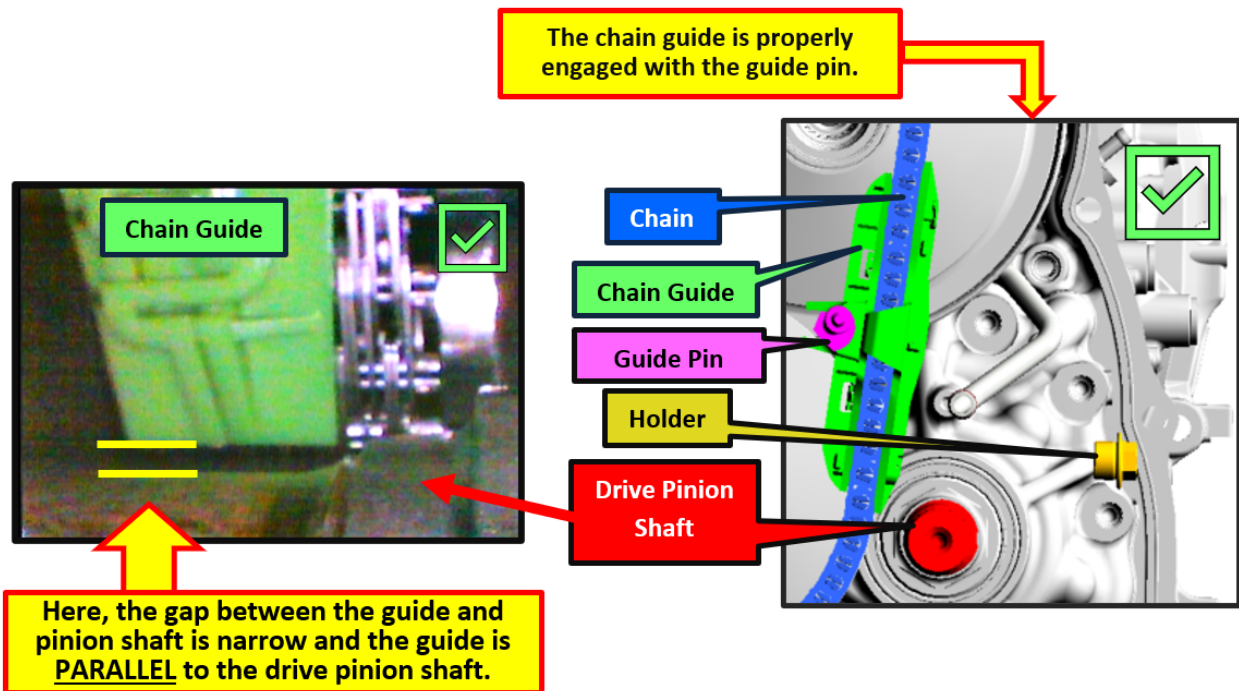
CORRECT GUIDE POSITIONING:

STEP 3E: Inspect the position of the lower end of the chain guide rail and the drive pinion shaft.

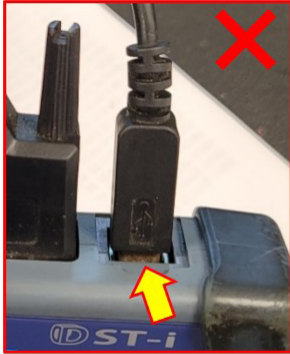
Corroded Connection

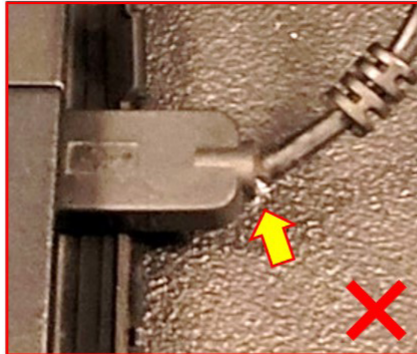
Exposed Wiring &
Incorrect Cable
