**RECREATIONAL VEHICLE
SAFETY RECALL NOTICE**

Safety Recall: 21V-247
Safety Advisory: 21-404
December 9, 2022

Aspen Trail Ramp Door Fasteners Repair Instructions

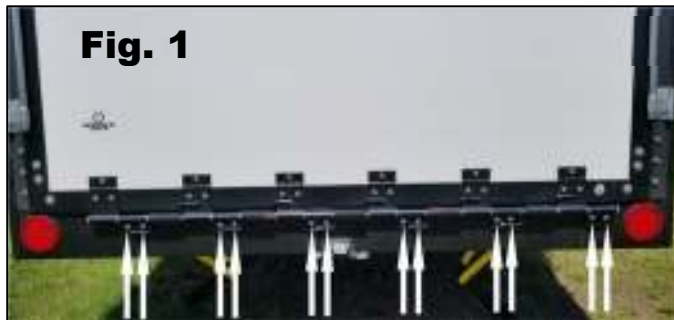
Fig. 1

It has been decided that the vehicles in the recall population have ramp door fasteners that were improperly installed and can strip out. Under certain conditions while loading items into the rear garage area, the ramp door screws can strip and pull out of the frame, leading to an increased risk of personal injury.

Install and finger tighten all 12 nuts on the existing ramp door hinge bolts. See Figure 1 and 2
