PALFINGER has become aware of a design issue on the base of the PW crane range (base type S419).

## 2 Affected Products

Base **S419G30SA** and its updated design **S419G30SB**

used on models PW 38001, PW 42001-SH, PW 38001EL, PW 50001-SH

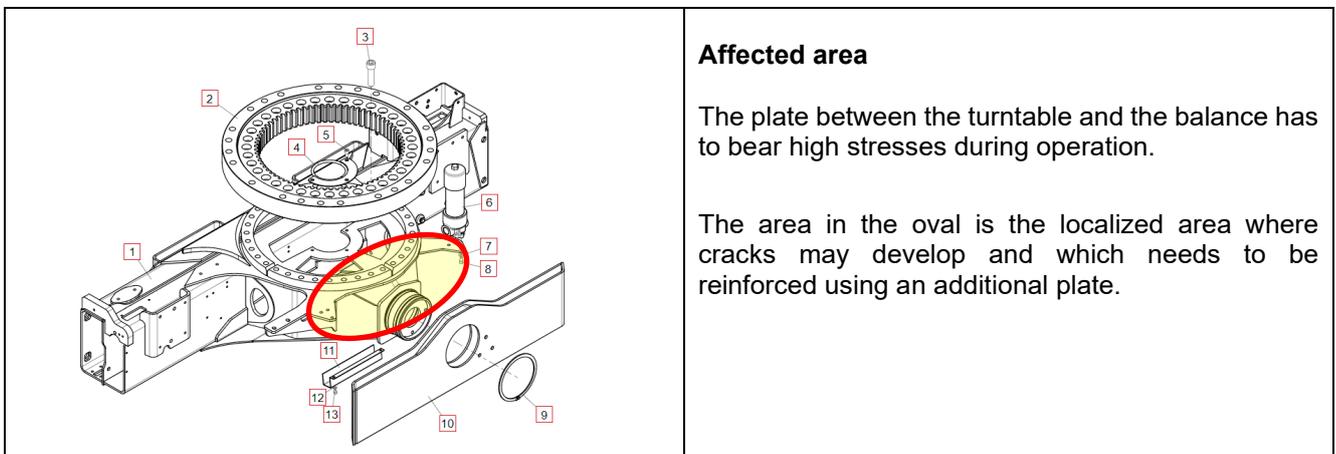
The affected area is located between the turntable and the balance. This area is accessible for an inspection without removing the crane, if the crane is mounted behind the cab.

It might be necessary to remove the crane to carry out a repair or a reinforcement if the area is not sufficiently accessible (such as on installations behind the cab).

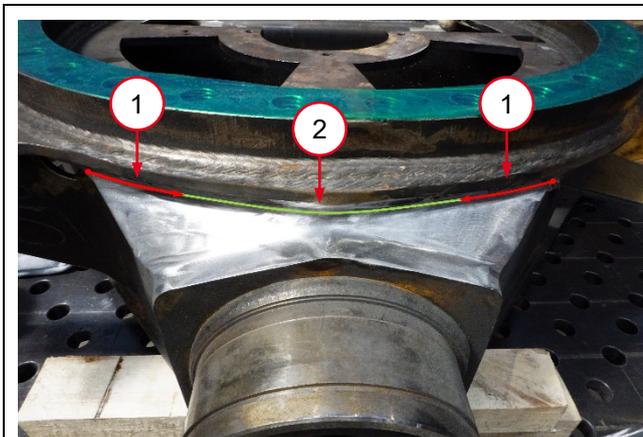
### Definition of the critical zone

Remove the paint before evaluating a crack for its priority. A crack is in the critical zone if it reaches into the critical area (1) in either the right or the left side.

This area (1) is **70 mm (2¾")** long on each side, measured on the welding seam from the outside towards the center.

If there is a crack that reaches into the critical area, the base cannot be repaired anymore. This is then a priority "A" case.

As long a crack is only present in the zone (2), a repair is possible.

In uncertain cases, use a dye penetration test to clearly identify whether a crack touches the zone or not.
