Product Safety Recall

N212345450 Accessory Floor Liner May Cause Unintended Acceleration

Release Date: December 2021

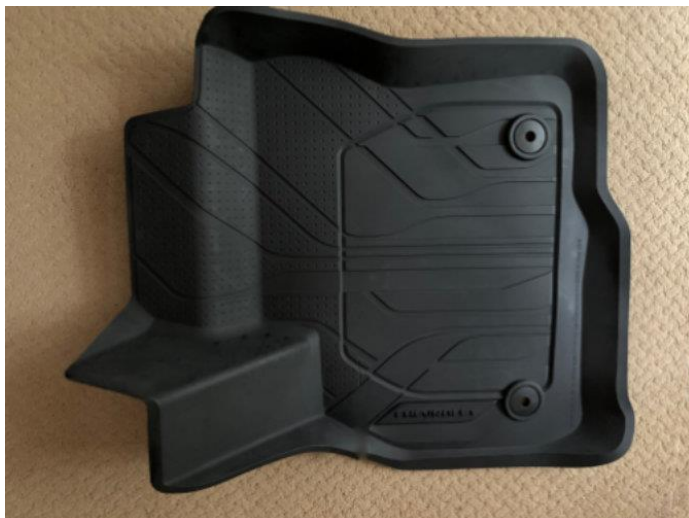
5911778

NOTE: This procedure only applies to the full liner type floor covering. Do not remove, destroy, or discard any other type of floor covering.

1. Remove the driver side accessory floor mat (liner).
