XDiavel Model Year 2016-2018 (all versions) Safety Recall Campaign SRV-RCL-21-001

Date: February 19, 2021

NHTSA Recall No. 21V-085

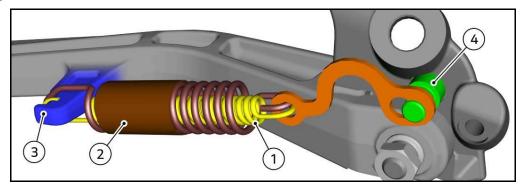
- 1. Position the bike on the rear paddock stand.
- 2. Release side stand return internal spring (1) and external spring (2) from hook (3) and pin (4) groove.

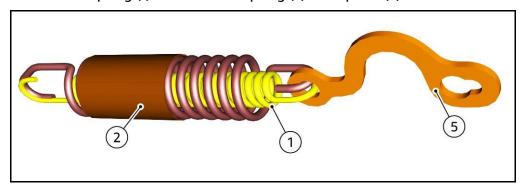
3. Remove internal spring (1) and external spring (2) from plate (5).

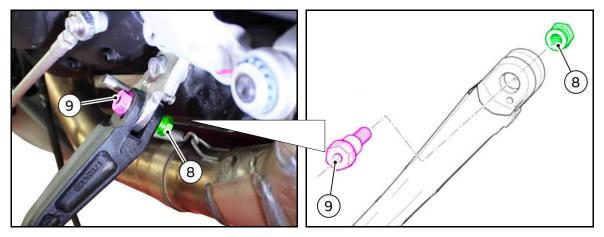
5. Remove **nut M8x1.25 (8)** and **pin M8x1.25 (9)** securing side stand to the relevant support bracket; then slide out side stand.

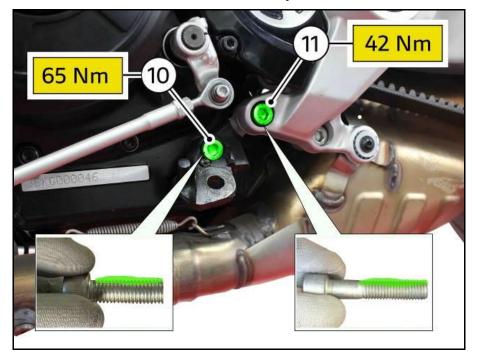
- 14. Tighten the M10x30 screw (10) to 65 Nm and certify.
- 15. Tighten the M10x50 screw (11) to 42 Nm and certify.

- 12. Apply LOCTITE 648 along the threading of screw M10x30 (10).
- 13. Apply LOCTITE 648 along the threading of screw M10x50 (11).

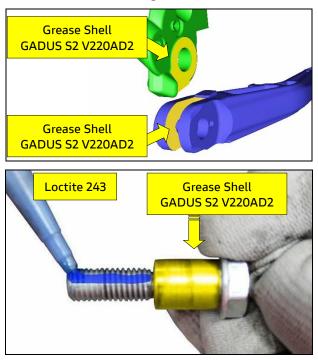
- 17. <u>Install the new side stand on the support bracket after applying Shell GADUS S2 V220AD2</u> (or equivalent) grease on the mating surfaces as shown in the figure.
- **18**. Take pin M8x1.25 and smear the cylindrical part with Shell GADUS S2 V220AD2 (or equivalent) grease and the whole threading with Loctite 243, as shown in the figure

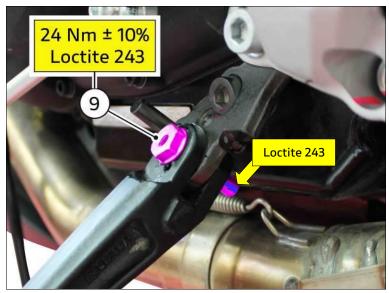
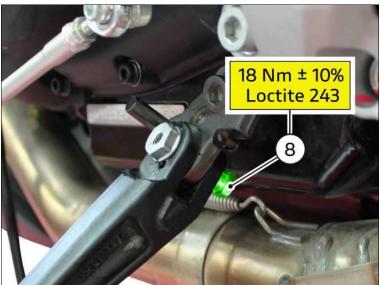
- 19. Insert pin M8x1.25 (9) and tighten to 24 Nm ± 10%.
- 20. Apply Loctite 243 on the threaded projection of pin M8x1.25 (8).
- 21. Start nut M8x1.25 (8) and tighten to 18 Nm ± 10%.

To tighten **nut M8x1.25 (7)**, you must hold **pin M8x1.25 (8)** to lock out rotation.

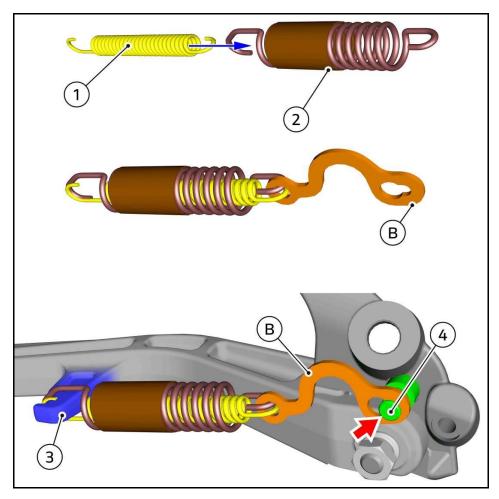
- 23. Insert internal spring (1) on external spring (2), aiming it as shown in the figure.
- 24. Hook spring ends to the new plate (B), aiming the parts as shown in the figure.
- 25. Fasten springs (1) and (2) to side stand hook (3) and insert the free hole of plate (B) inside the special groove on plate pin (4), as shown in the figure.

Plate (B) must be positioned as indicated by the red arrow.

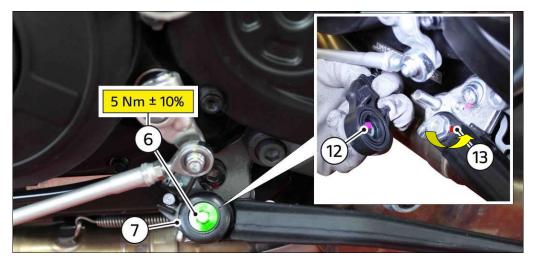
- **26.** Install **switch (7)** on the side stand as shown in the figure.
- 27. Tighten special screw (6) to of 5 Nm ± 10%.

Insert the timing pin (12) of the switch in hole (13) of the stand.
