Product Safety Recall

N202325160 Battery Cable Short Circuit

Release Date: March 2021

| Condition | General Motors has decided that a defect which relates to motor vehicle safety exists in certain 2021 model year Chevrolet Express and GMC Savana vehicles with 6.6L gas engines. In certain circumstances, anti-rotation tabs on the positive battery cable terminals may come into contact with a fuse block assembly attachment post, causing a short circuit. Clearance between the positive battery cable anti-rotation tab and the fuse attachment posts is small enough to allow contact in certain situations. Drivers may get a low battery voltage warning or experience a dead battery. A short-circuit of a positive battery cable to a fuse attachment post can cause battery drain or may lead to an underhood fire. |

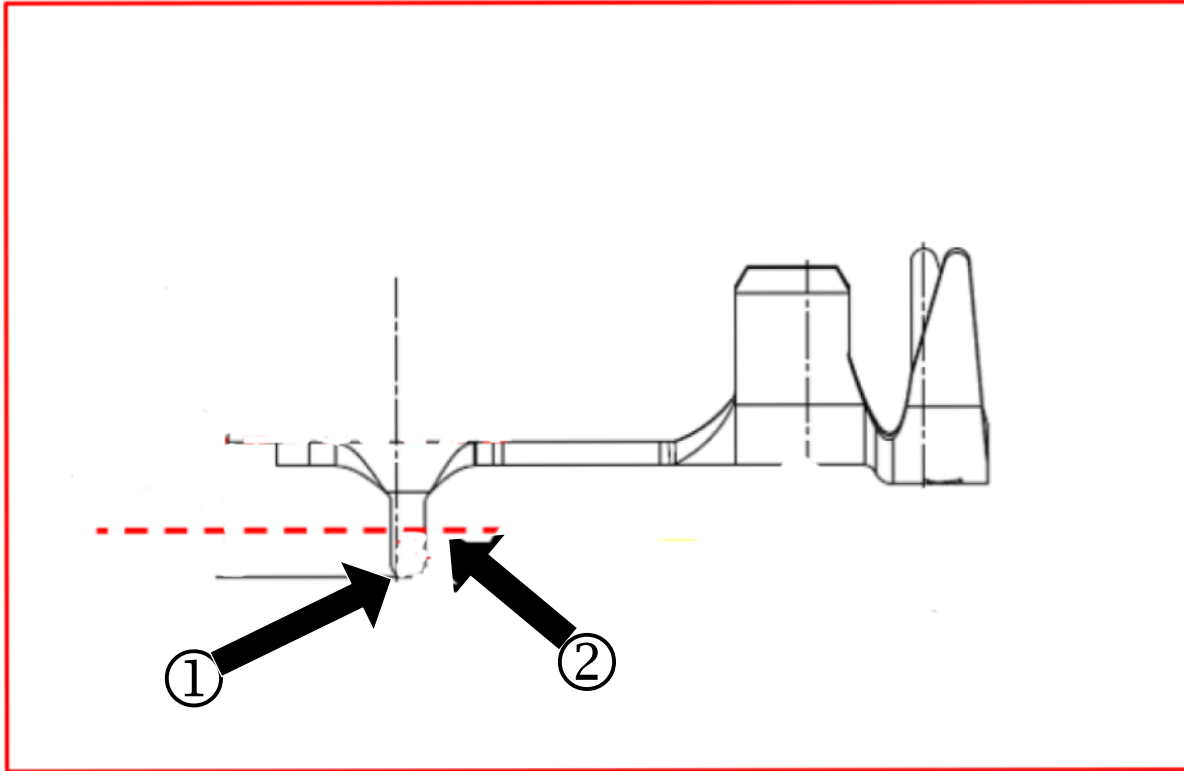
5779100

Important: The following measurement is critical to a correct repair. THE CUT MUST BE MADE IN THE EXACT LOCATION SHOWN IN THE GRAPHIC. DO NOT cut the anti-rotation tab flush. Cutting the tab flush may cause the cables to rotate and contact the fasteners or the Mega fuse mounting studs.

7. Starting from the bottom of the tab (1), measure up 4.5mm (2) from the end of the tab and scribe a line.

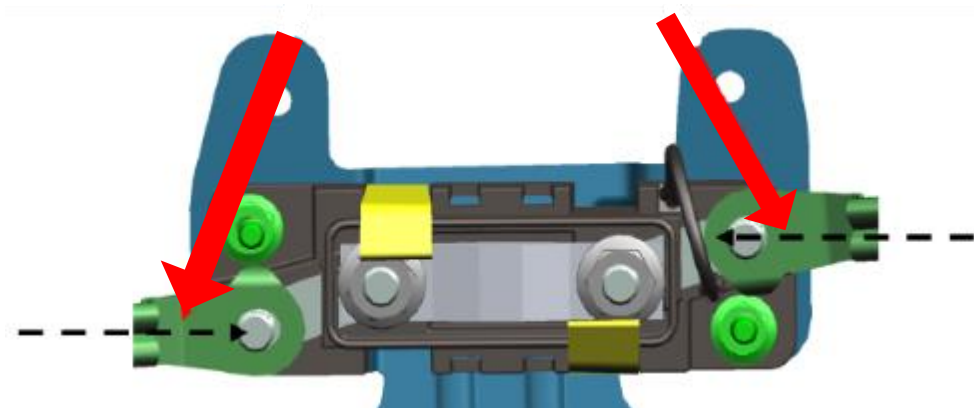
5779104

Note: When tightening the fasteners, hold the cables in a manner so they do not contact the studs as shown in the graphic above.

13. Tighten the fasteners to 20 Nm (15 lb ft).
