Product Safety Recall

N202325160 Battery Cable Short Circuit

Release Date: April 2021

Condition	General Motors has decided that a defect which relates to motor vehicle safety exists in certain 2021 model year Chevrolet Express and GMC Savana vehicles with 6.6L gas engines. In certain circumstances, anti-rotation tabs on the positive battery cable terminals may come into contact with a fuse block assembly attachment post, causing a short circuit. Clearance between the positive battery cable anti-rotation tab and the fuse attachment posts is small enough to allow contact in certain situations. Drivers may get a low battery voltage warning or experience a dead battery. A short-circuit of a positive battery cable to a fuse attachment post can cause battery drain or may lead to an underhood fire.
Correction	Dealers will inspect the positive battery cable anti-rotation tab to determine if it has been previously cut too short or completely cut off. Dealers will remove a portion of the anti-rotation tab on both positive battery cable terminals near the engine compartment fuse block assembly attachments if not previously repaired.

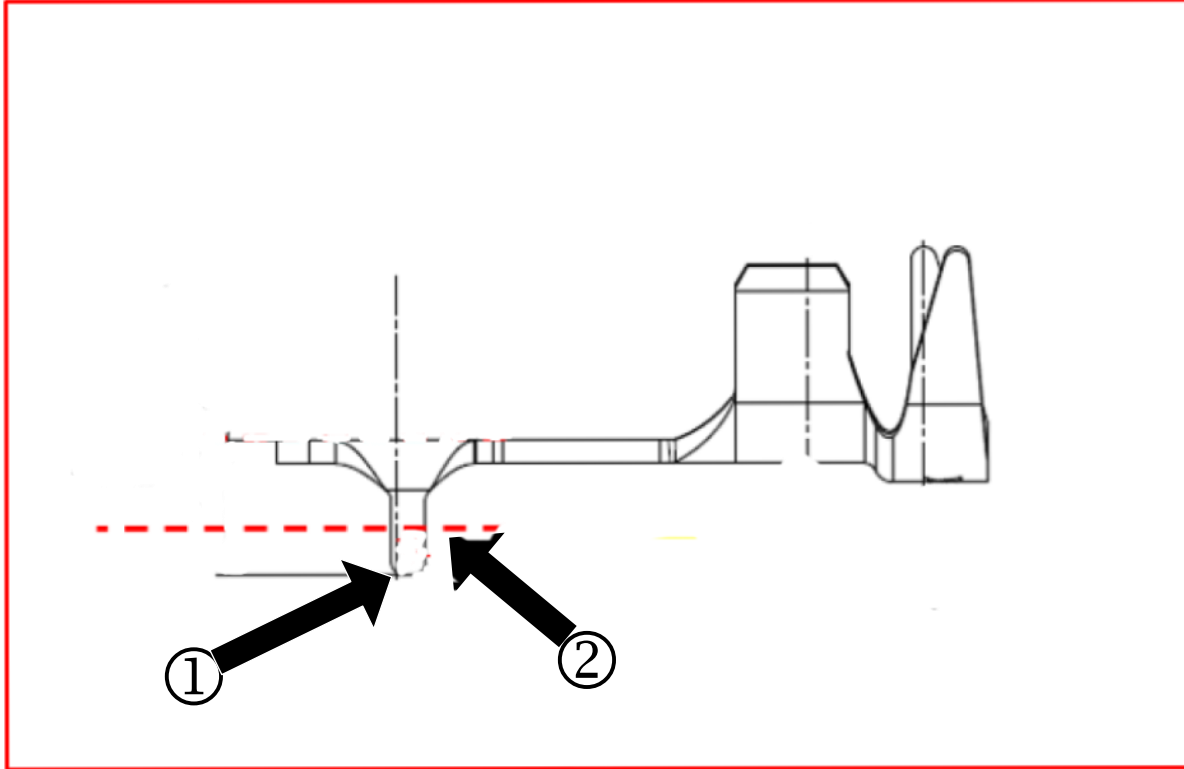
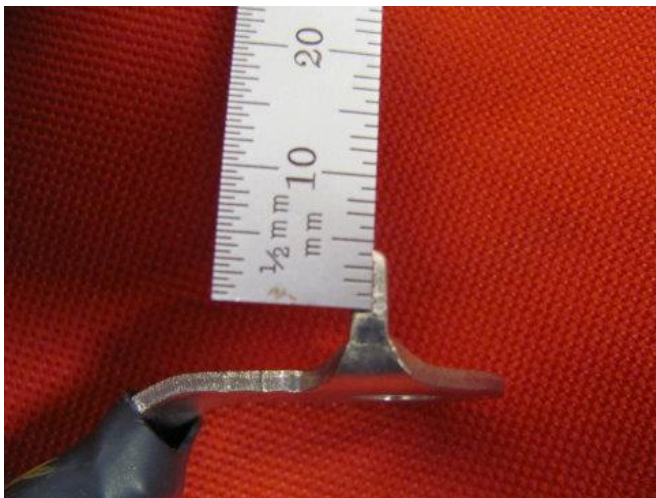
5779100

Important: The following measurement is critical to a correct repair. THE CUT MUST BE MADE IN THE EXACT LOCATION SHOWN IN THE GRAPHIC. DO NOT cut the anti-rotation tab flush. Cutting the tab flush may cause the cables to rotate and contact the fasteners or the Mega fuse mounting studs.

7. Starting from the bottom of the tab (1), measure up 4.5mm (2) from the end of the tab and scribe a line.
