Product Safety Recall

N202325160 Battery Cable Short Circuit

Release Date: May 2021

Revision: 03

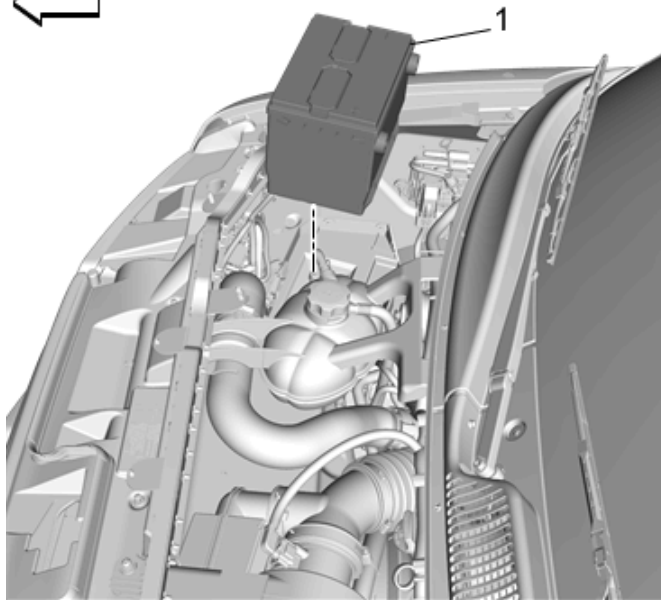
4597853

1. Remove the vehicle battery (1). Refer to *Battery Replacement* in SI.

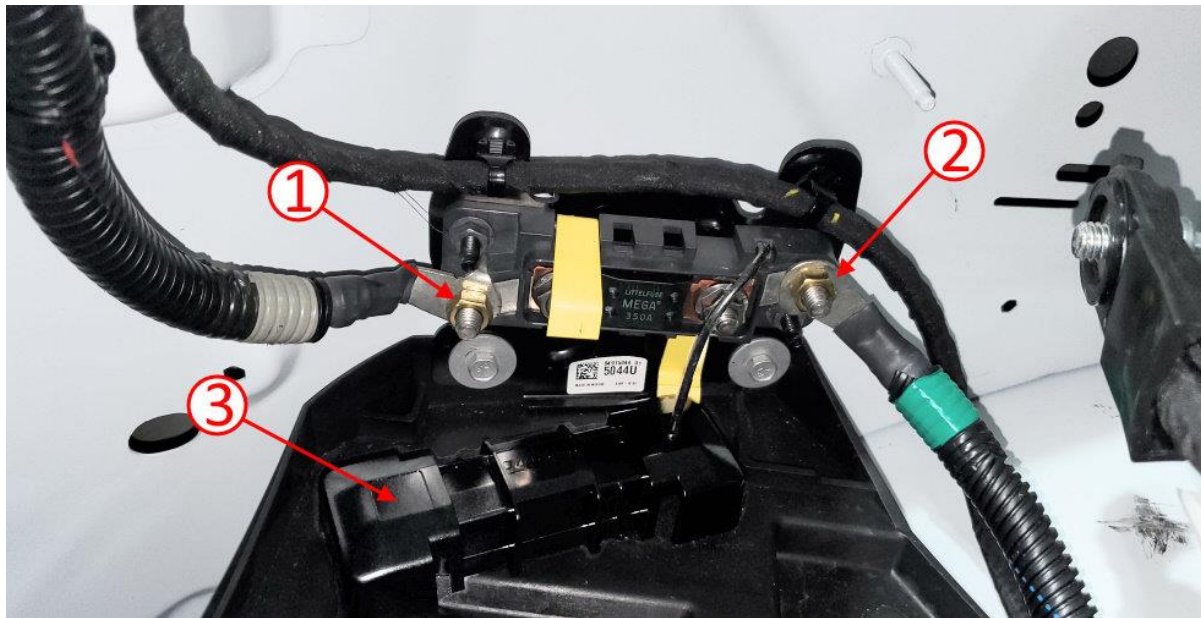
5694188

2. Locate the Mega Fuse assembly mounted on the inner fender.
3. Remove the fuse cover (3).
4. Remove the fasteners that connect the two cables to the fuse block (1 and 2).

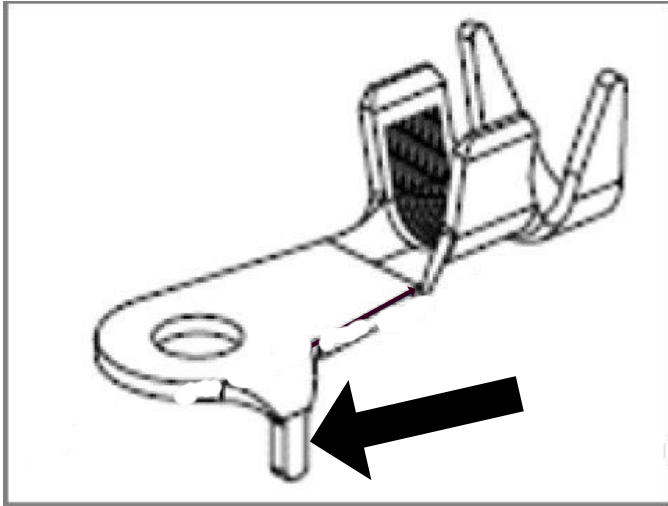
5779095

5. With the cables disconnected, locate the anti-rotation tabs on both cable ends.
6. Inspect the length of the terminal anti-rotation tabs on both cable ends.

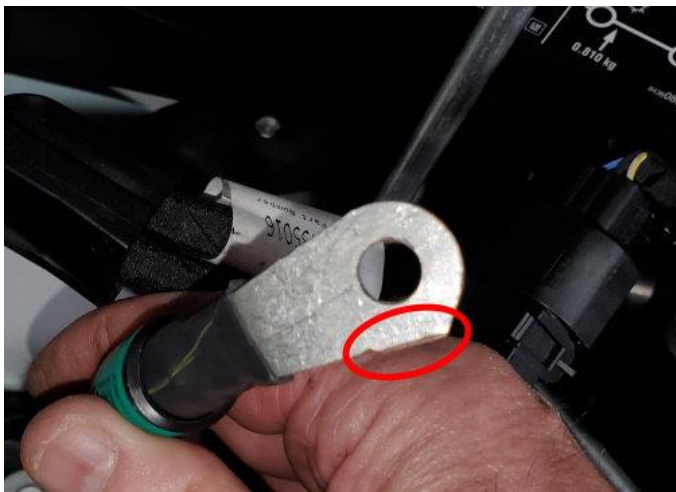
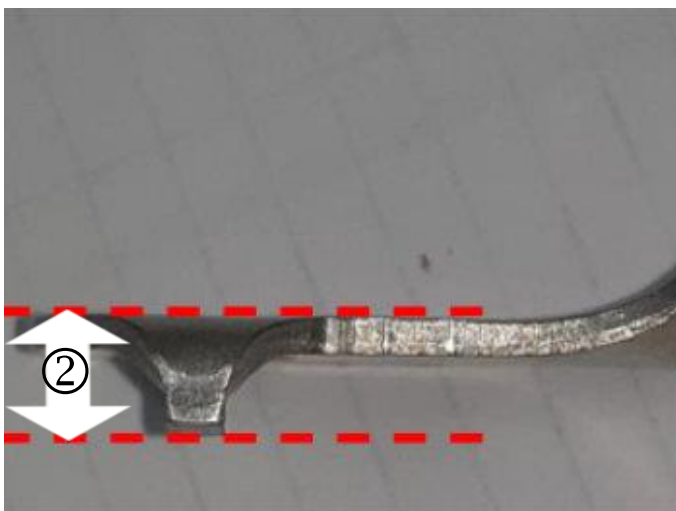
- If one or both anti-rotation tabs has been cut completely off or is trimmed to less than 6mm in length (2), the battery cable assembly will require replacement. Replace the battery positive cable, refer to Battery Positive

Cable Replacement in SI. The new service part anti-rotation tab is trimmed to the correct length, once the new cable is installed, no further action is required.

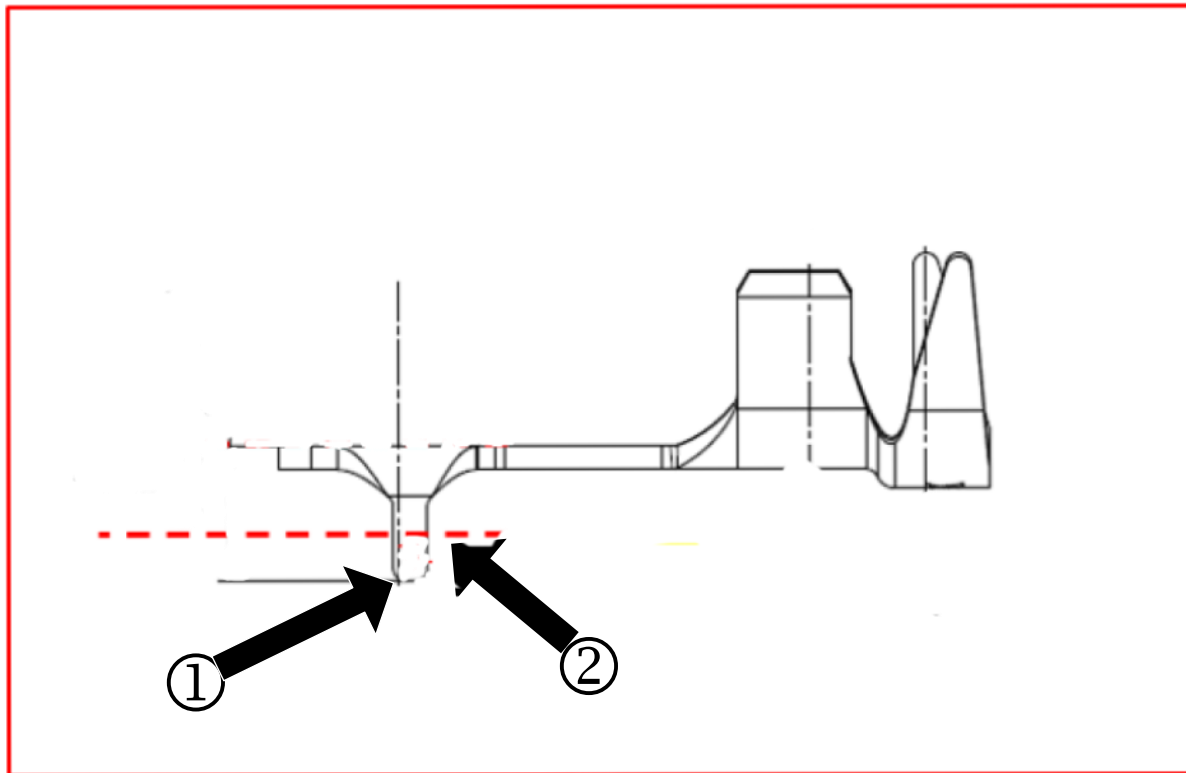
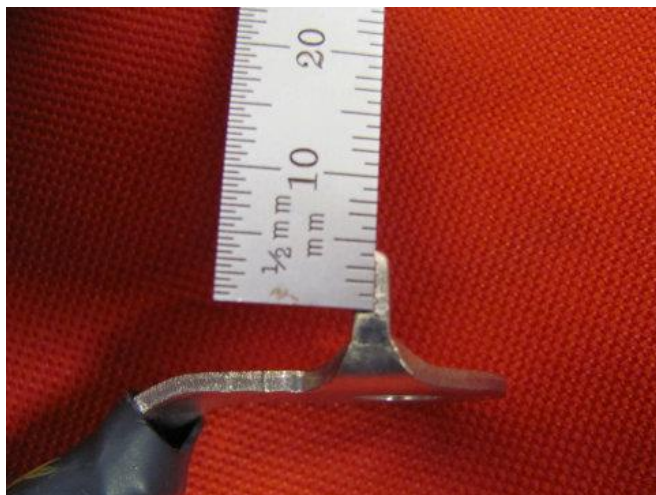
Important: The following measurement is critical to a correct repair. THE CUT MUST BE MADE IN THE EXACT LOCATION SHOWN IN THE GRAPHIC. DO NOT cut the anti-rotation tab flush. Cutting the tab flush may cause the cables to rotate and contact the fasteners or the Mega fuse mounting studs.

7. Starting from the bottom of the tab (1), measure up 4.5mm (2) from the end of the tab and scribe a line.

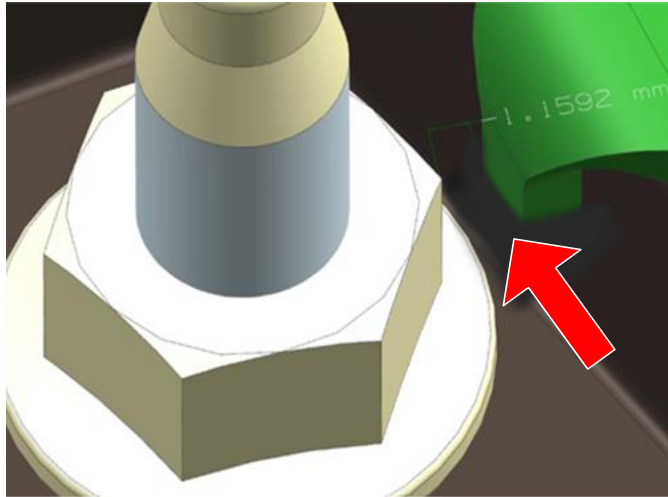
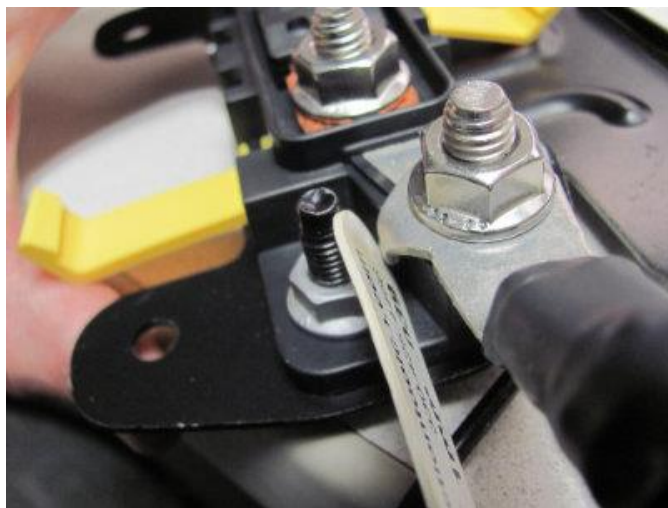
IMPORTANT: With both fasteners tightened to specification, **make sure there is at least 1mm clearance** between the anti-rotation tab and the nut at both locations. If the clearance is less than 1mm, remove the cable and further trim the tab as required.
