Product Safety Recall

N202325161 Battery Cable Short Circuit

Release Date: April 2021

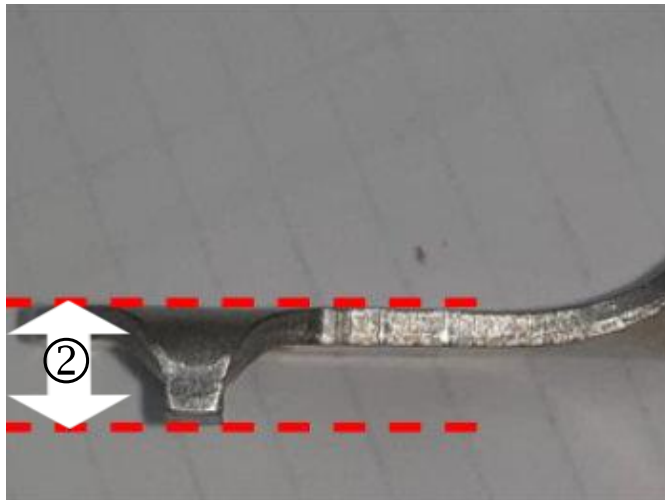
5779103

* If both anti-rotation tabs are trimmed to the correct 6mm length (2), no further action is required. Reinstall the cables following steps 6-9 below.

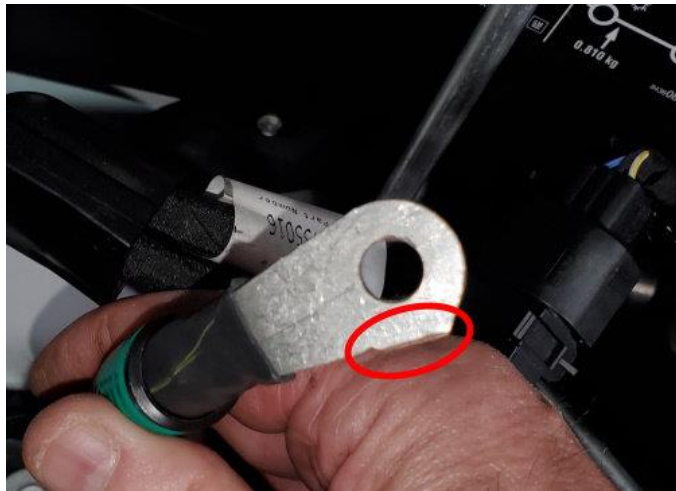
5693961

* If one or both anti-rotation tabs has been cut completely off, or measures less than 6mm as shown in the first graphic in this step, replace the positive battery cable assembly. Refer to Battery Positive Cable Replacement in SI. When installing the new cable assembly, follow steps 6-9 below.
