# Product Safety Recall

## N212330040 Driver Seat Belt Cable May Separate

Release Date: April 2021

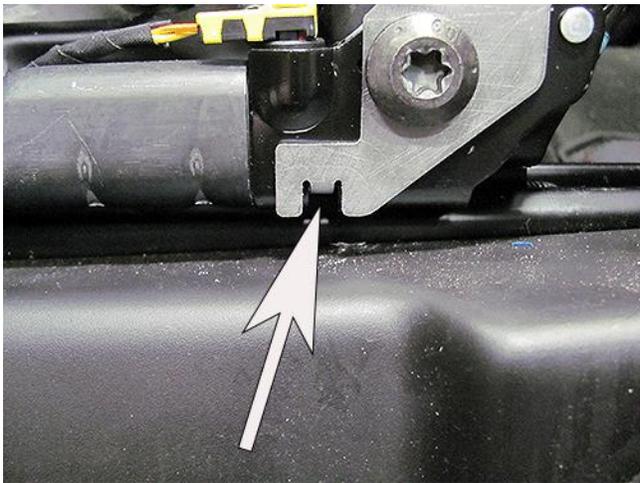
4551063

#### Procedure for Vehicles Repaired Under Recall # 15822C and #18156

**NOTE:** If a tensioner bracket was installed as part of a previous service, discard the bracket. The new replacement front seat belt anchor plate tensioner design eliminates the need for the bracket.

1. Replace the driver side front seat belt anchor plate tensioner. Refer to *Front Seat Belt Anchor Plate Tensioner Replacement* in SI.
2. Scrap the removed driver side front seat belt anchor plate tensioner. Refer to *Front Seat Belt Anchor Plate Tensioner Replacement* in SI.

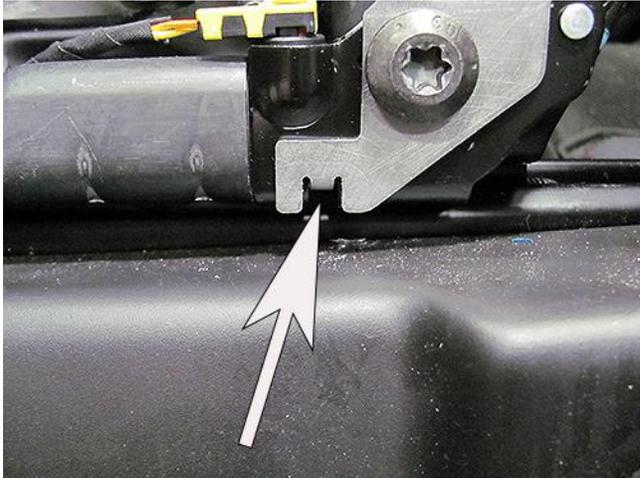
4551063

### Procedure for Vehicles Repaired Under Recall # 15822

**NOTE:** If a tensioner bracket was installed as part of a previous service, discard the bracket. The new replacement front seat belt anchor plate tensioner design eliminates the need for the bracket.

1. Remove the driver side front seat belt anchor plate tensioner. Refer to *Front Seat Belt Anchor Plate Tensioner Replacement* in SI.
2. Transfer the seat switch (if equipped) and hardware onto the new seat side shield panel. Refer to *Front Seat Cushion Outer Finish Cover Replacement* in SI.
3. Complete the installation of the new seat belt anchor plate tensioner and new seat cushion outer finish cover. Refer to *Front Seat Belt Anchor Plate Tensioner Replacement* in SI.
4. Scrap the removed driver side front seat belt anchor plate tensioner. Refer to *Front Seat Belt Anchor Plate Tensioner Replacement* in SI.
