Product Safety Recall

N202321200 Driver Side Roof Rail Airbag Bolts Not Installed

Release Date: May 2021

Condition	General Motors has decided that a defect which relates to motor vehicle safety exists in certain 2010–2015 and 2017 model year Buick Enclave vehicles; 2010–2015 and 2019 model year Chevrolet Traverse vehicles; and 2011–2014 and 2016 model year GMC Acadia vehicles. One or two of the weld nuts that secure the left roof-rail airbag to the vehicle might be damaged, out of position, or missing. If the roof-rail airbag is not properly secured to the vehicle, the airbag may not perform as intended, increasing the risk of injury in certain crash conditions.
Correction	Dealers will inspect roof-rail airbag attachments and provide or replace any found to be missing, damaged or out of position.

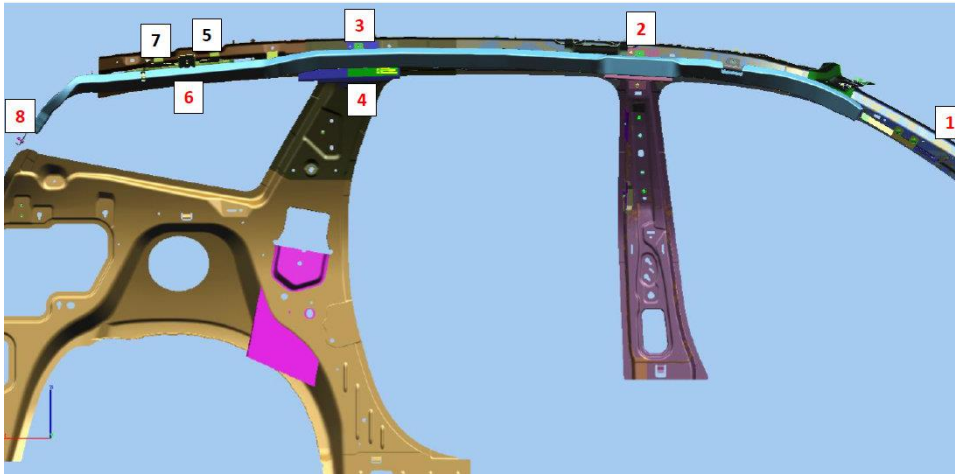
5834454

2010 - 2011 Traverse and Enclave bolt locations (Qty=8 total). Red Numbered locations indicate an M6x20mm bolt, Black Numbered locations indicate an M6x14.5mm bolt.

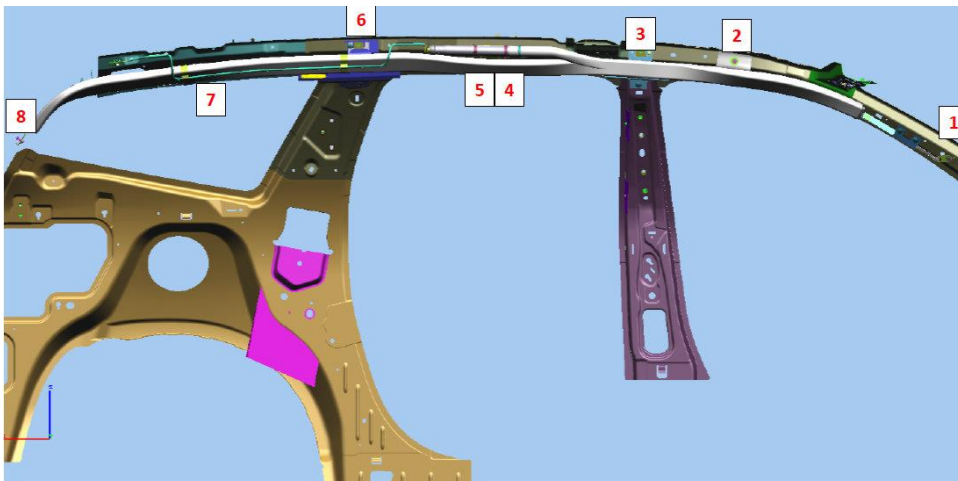
5834456

2012 - 2017 Traverse and Enclave bolt locations (Qty=8 total). Red Numbered locations indicate an M6x20mm bolt.

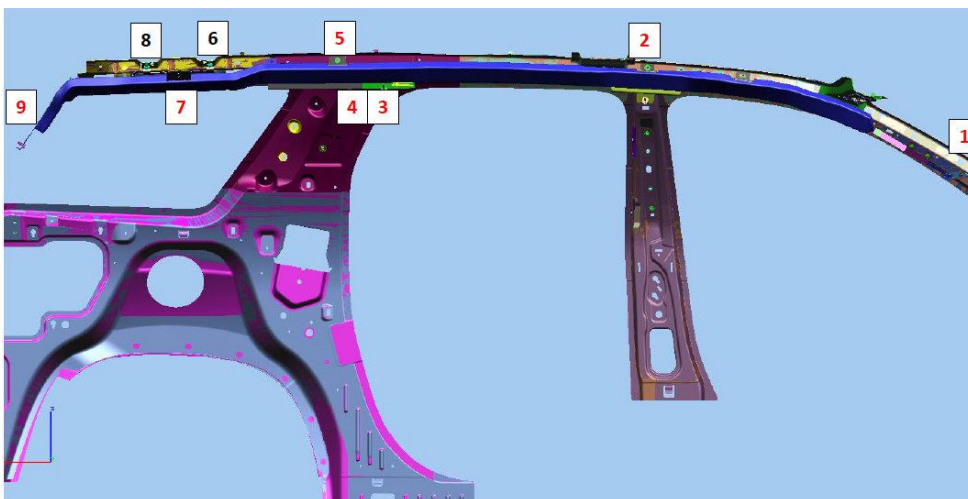
5834458

2011 Acadia bolt locations (Qty=9 total). Red Numbered locations indicate an M6x20mm bolt, Black Numbered locations indicate an M6x14.5mm bolt.

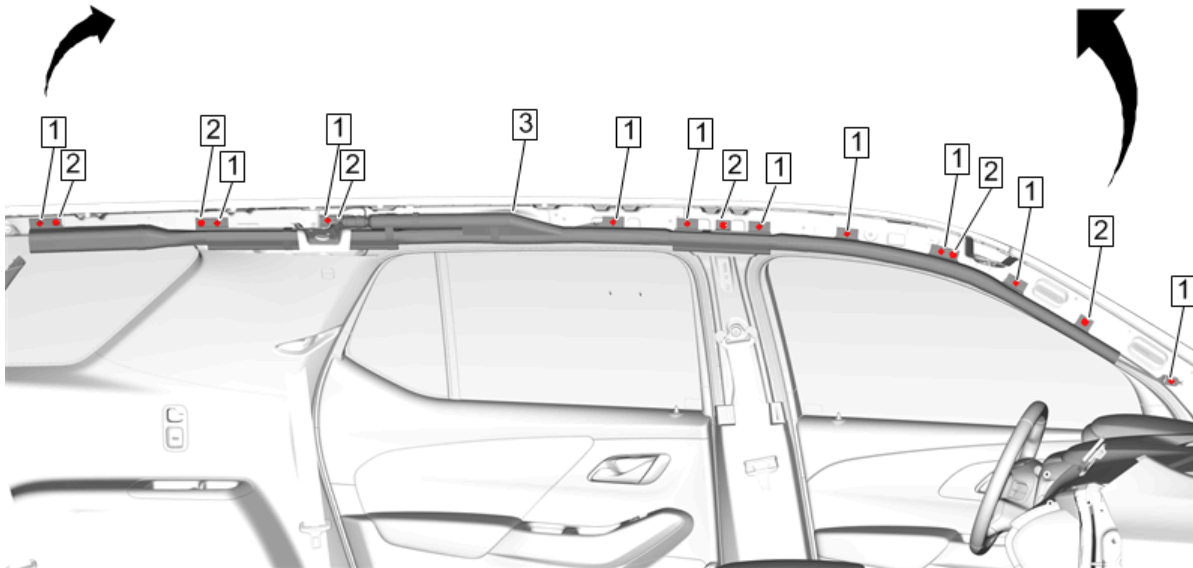
4774019

Model Year 2019 Traverse (1) Bolt 10 Locations

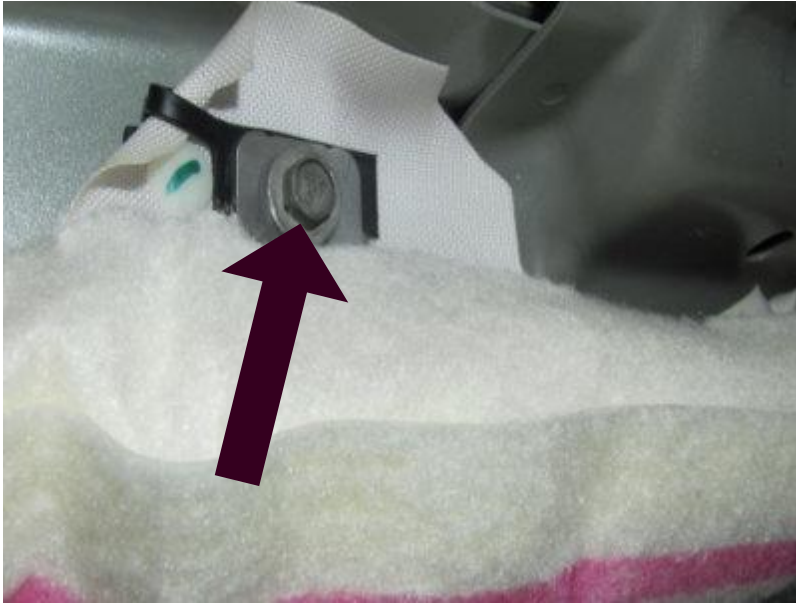
5823445

- Verify the fastener is installed into the body and the weld nut is present.

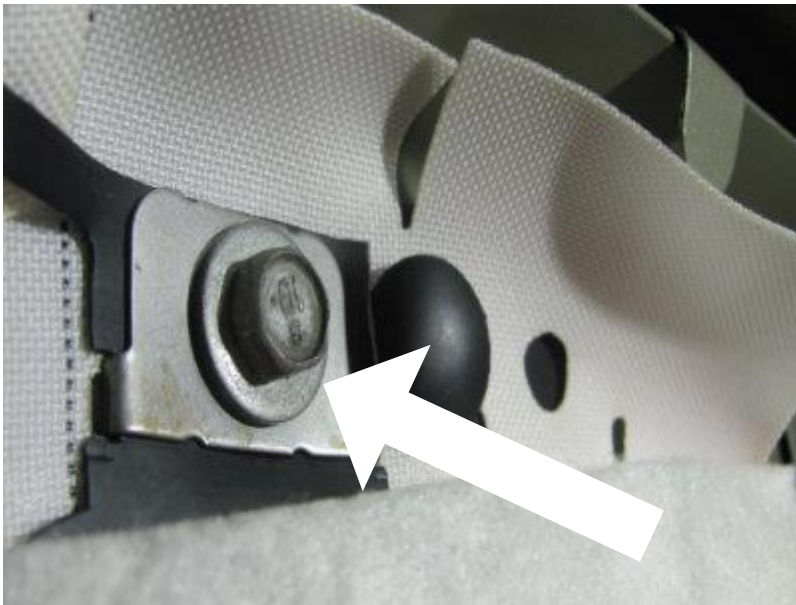
5823617

- Verify that the washer is secure and tightened down onto the mounting tab.
- 3. If a bolt is not present or is present on the roof rail airbag mounting tab, but not installed into the weld nut, and the weld nut is correctly installed, discard any existing bolts and proceed to the Thread Repair section below. The bolt retaining washer holding the bolt to the roof rail airbag mounting tab, if present, should be discarded and will not need replacement.
