# Product Safety Recall

## N202325530 Speed Limiting Exceeds Tire Rating

Release Date: May 2021

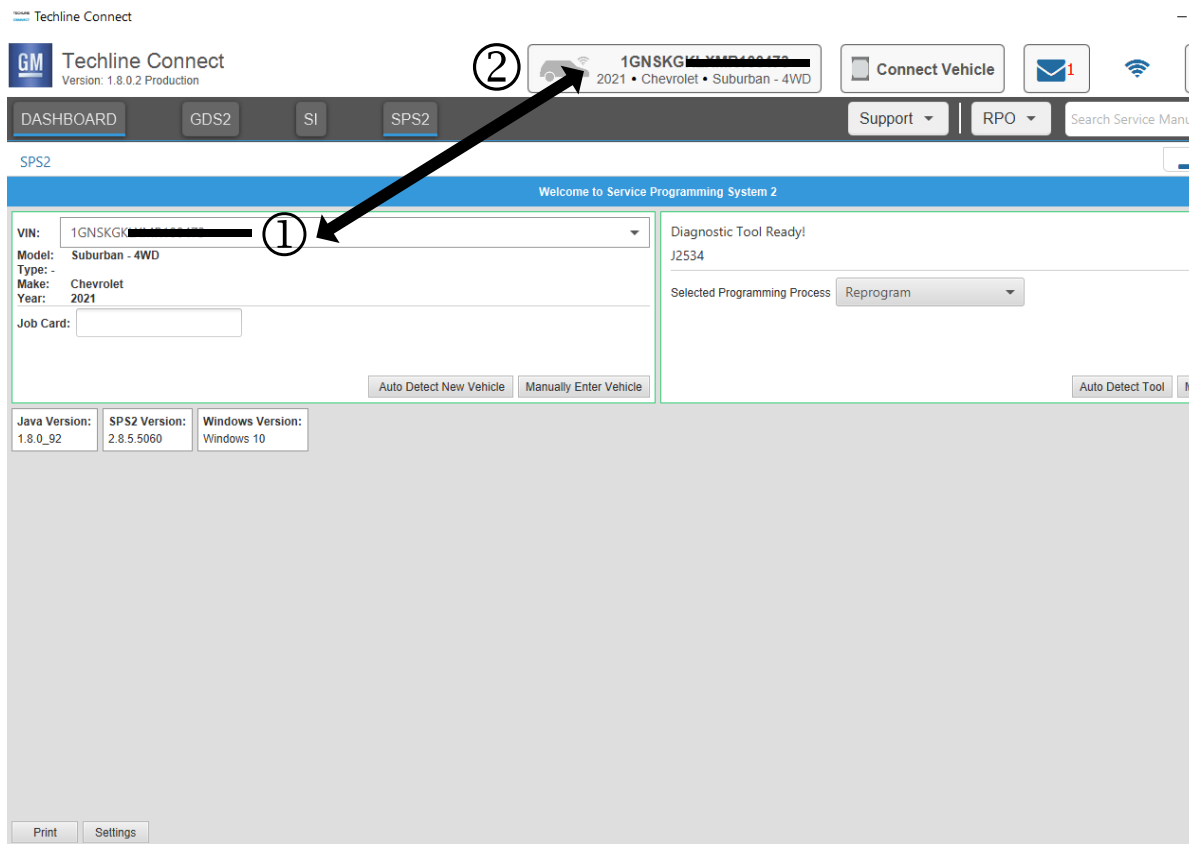
5743643

**Caution:** Be sure the VIN selected in the drop down menu (1) is the same as the vehicle connected (2) before beginning programming.
