N212336230 Improper Inspection for Overcured Tires

Release Date: August 2021 Revision: 02

Condition	General Motors has decided that a defect which relates to motor vehicle safety exists in certain
	Continental tires installed as original equipment on certain 2019 model year Chevrolet Silverado 1500
	and GMC Sierra 1500 vehicles. According to the tire manufacturer, Continental Tires the Americas
	(Continental), the affected tires may have an overcure condition and Continental has initiated a safety
	recall for these tires. Due to an omission in the service bulletin for General Motors' recall N212329050,
	dealers may have failed to identify and replace, as necessary, suspect tires on 2019 Silverado and Sierra
	vehicles that were inspected under that recall. According to Continental, overcured tires may experience
	a carcass break in the sidewall with sudden air loss or could develop a belt edge separation which could
	lead to partial or full tread/belt loss. These conditions may increase the risk of a crash.

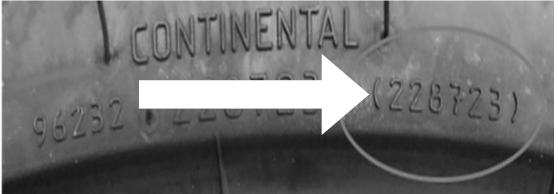
5672012

This procedure involves inspecting the tire sidewall for manufacturing information. The mold number, in parenthesis along with the last four numbers in the DOT stamp (Date Code) indicate if the tire is involved in this recall. See the examples in the photographs below.

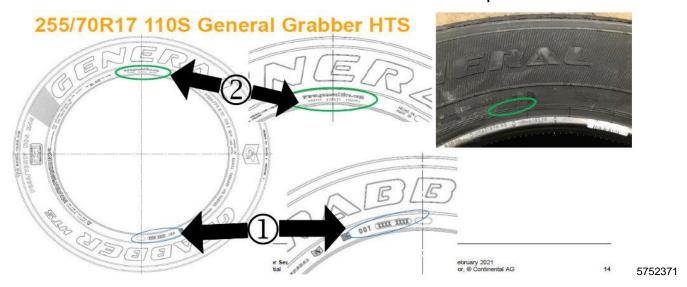
The tires must contain the exact DOT week and mold number combination as specified in the chart above.

- 1. Inspect the tire sidewall as shown and verify the mold number (2) and the DOT week (1).
- 2. If the mold number and DOT date match the *Affected DOT wk(s) Mold # combination* in the tire information chart, replace the tire.
