# Product Safety Recall

## N212333900 Loss of Power Steering Assist

**Release Date:** July 2021

<b>Condition</b>	General Motors has decided that a defect which relates to motor vehicle safety exists in certain 2021 model year Chevrolet Suburban and Tahoe vehicles; and GMC Yukon and Yukon XL vehicles. These vehicles have a software issue that can cause loss of power steering assist at startup or while driving. If power steering assist is lost, manual steering control is still available. However, increased steering effort is required, particularly at lower speeds, increasing the risk of a crash.
<b>Correction</b>	GM will update the software in the vehicles' power steering module. Owners who have accepted applicable terms and conditions will have the opportunity to accept these software changes using wireless over-the-air (OTA) technology without having to bring their vehicle to a dealership. Alternatively, owners may schedule to have the updates performed at a GM dealer.

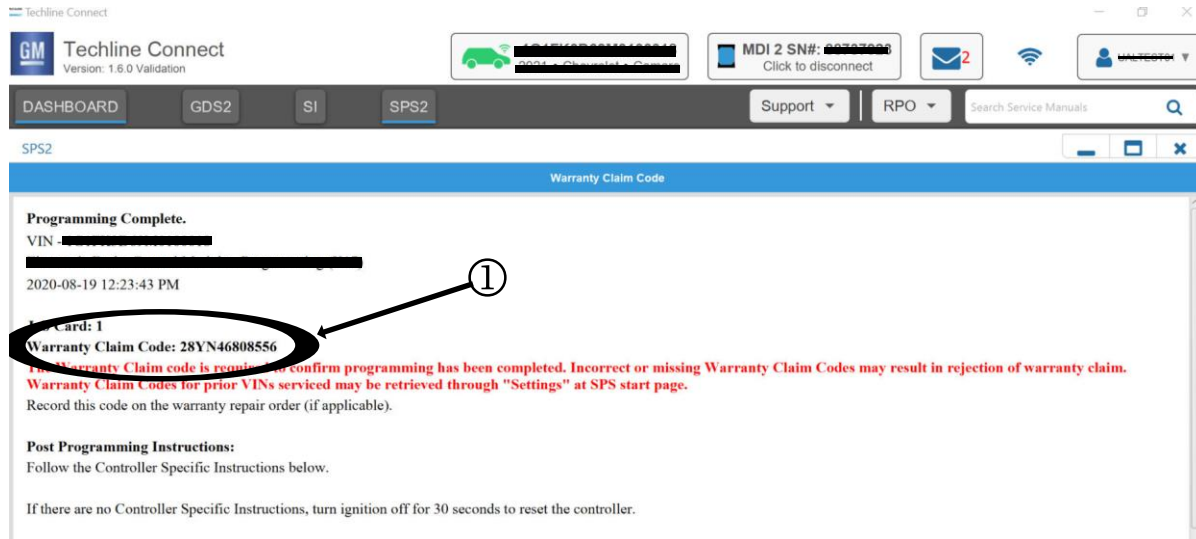
5644478

**Note:** The screenshots above are an example of module programming and may not be indicative of the specific module that is being programmed. Module selection and VIN information have been blacked out.

**Important:** To avoid warranty transaction rejections, you **MUST** record the warranty claim code provided on the Warranty Claim Code (WCC) screen shown above on the job card. Refer to callout 1 above for the location of the WCC on the screen.

1. Reprogram the Power Steering Control Module. Refer to *K43 Power Steering Control Module: Programming and Setup* in SI.
