Product Safety Recall

N212333900 Loss of Power Steering Assist

Release Date: June 2021

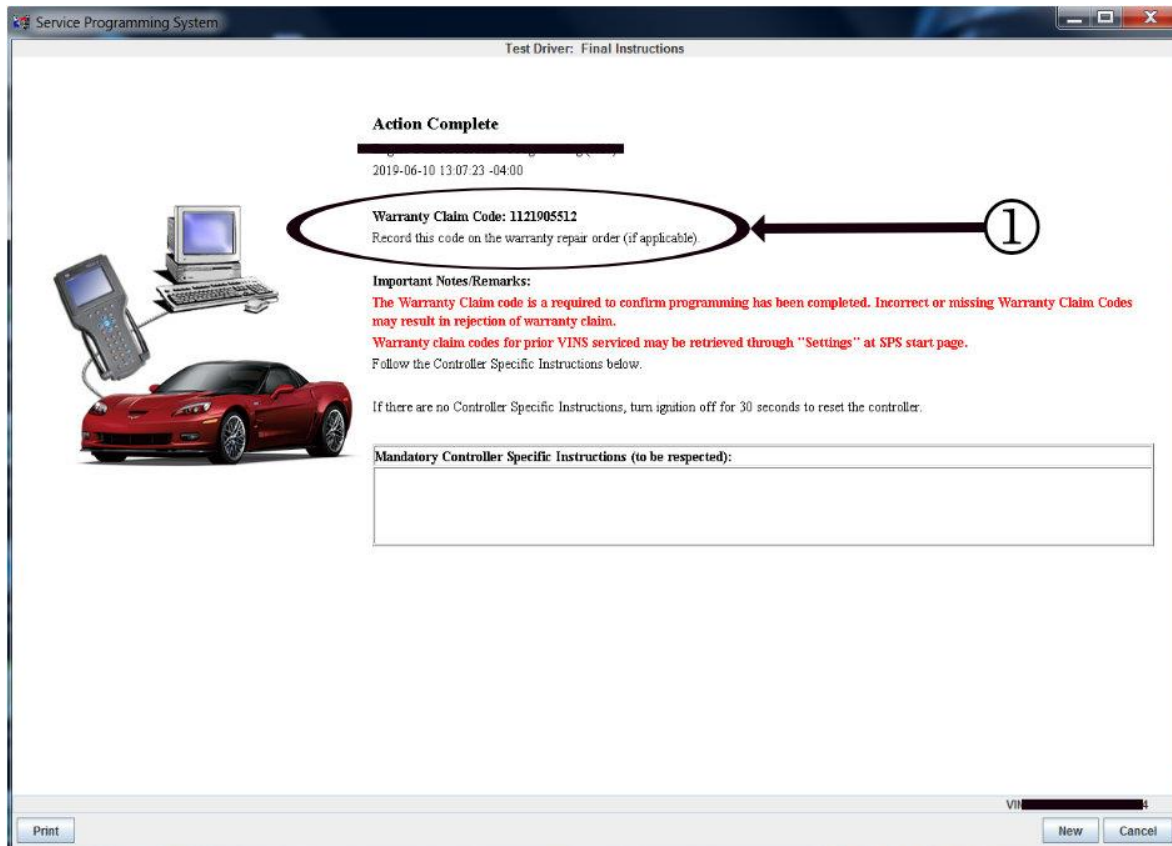
5431209

Important: To avoid warranty transaction rejections, you **MUST** record the warranty claim code provided on the Warranty Claim Code (WCC) screen shown above on the job card. Refer to callout 1 above for the location of the WCC on the screen.

2. Record SPS Warranty Claim Code on job card for warranty transaction submission.
