Product Safety Recall

N212340980 Rear Toe Link Separation

Release Date: December 2021 **Revision:** 03
Revision Description: This bulletin has been updated in the warranty and service procedure sections. Please discard all previous copies of N212340980.

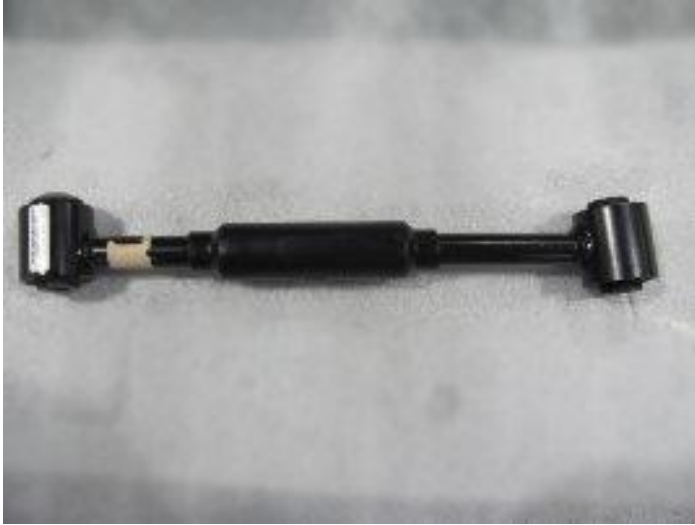
5880371

Over-mold service part

IMPORTANT: The new rear suspension links are non-adjustable. Rear toe adjustment is to be accomplished using the camber adjustment. Please refer to the revised rear alignment specifications provided in the service procedure below. There are two types of service parts that are approved for this repair. The over-mold part and the solid link part both perform and function the same, only the manufacturing processes differ. They must be installed in pairs, do not mix the over-mold and solid link service parts on the same vehicle.

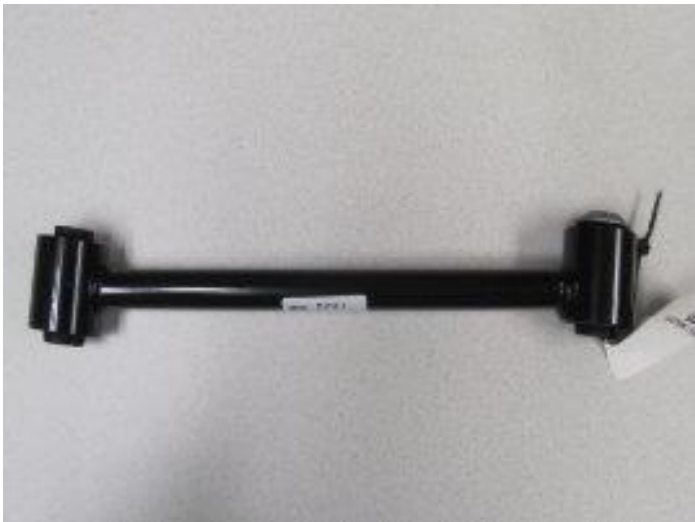
5903821

Solid link service part
