Product Safety Recall

N212340980 Rear Toe Link Separation

Release Date: October 2021
Revision Description: This bulletin has been revised in the parts, warranty, and service procedure sections and the customer letter has been added. Please discard all previous copies of N212340980.
Revision: 02

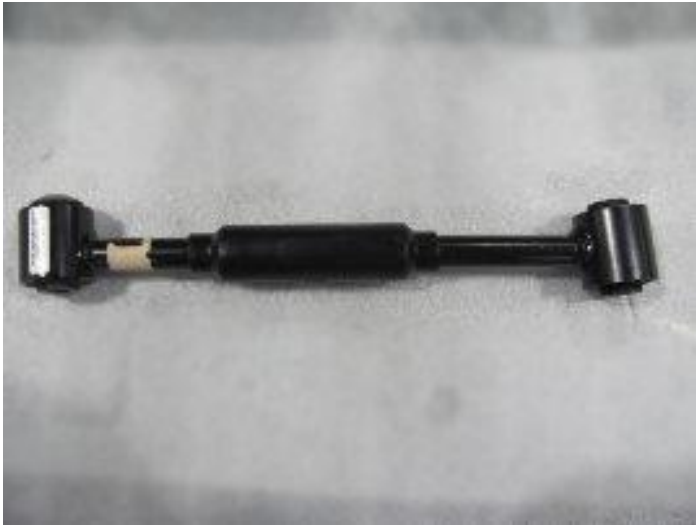
5880371

Over-mold service part

IMPORTANT: The new rear suspension links are non-adjustable. Rear toe adjustment is to be accomplished using the camber adjustment. Please refer to the revised rear alignment specifications provided in the service procedure below. There are two types of service parts that are approved for this repair. The over-mold part and the solid link part both perform and function the same, only the manufacturing processes differ. They must be installed in pairs, do not mix the over-mold and solid link service parts on the same vehicle.

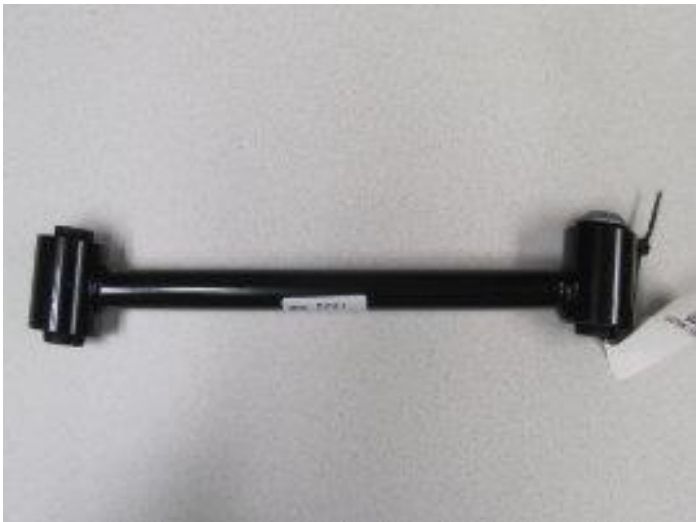
5903821

Solid link service part
