Product Safety Recall

N212340980 Rear Toe Link Separation

Release Date: January 2022 **Revision:** 04
Revision Description: The service procedure Alignment Settings has been updated in this bulletin. Please discard all previous copies of N212340980.

Condition	General Motors has decided that a defect, which relates to motor vehicle safety, exists in certain 2010 to 2016 model year Cadillac SRX and 2011 to 2012 Saab 9-4x vehicles. These vehicles may have received improper service requiring adjustment of a rear suspension toe link. In rare cases, dealers or independent repair shops may not have followed GM’s published procedures for torquing the jam nut in the toe link adjusters to the proper specification. A loose toe link can cause the vehicle to sway or wander at highway speeds or allow water or other corrosive elements to enter the threads within the adjuster. If a toe link is improperly adjusted, corrosion combined with vehicle motion may eventually cause the threads within the link to wear and loosen. In very rare cases with continued use, the link could separate. Separation while the vehicle is being driven increases the risk of a crash.

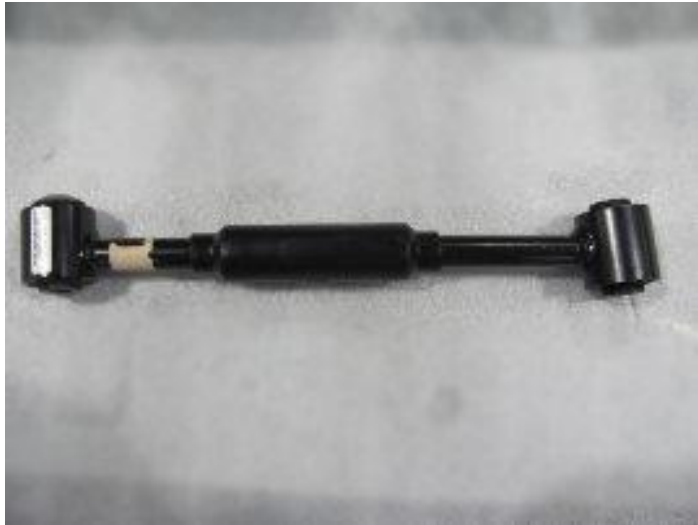
5880371

Over-mold service part

IMPORTANT: The new rear suspension links are non-adjustable. Rear toe adjustment is to be accomplished using the camber adjustment. Please refer to the revised rear alignment specifications provided in the service procedure below. There are two types of service parts that are approved for this repair. The over-mold part and the solid link part both perform and function the same, only the manufacturing processes differ. They must be installed in pairs, do not mix the over-mold and solid link service parts on the same vehicle.

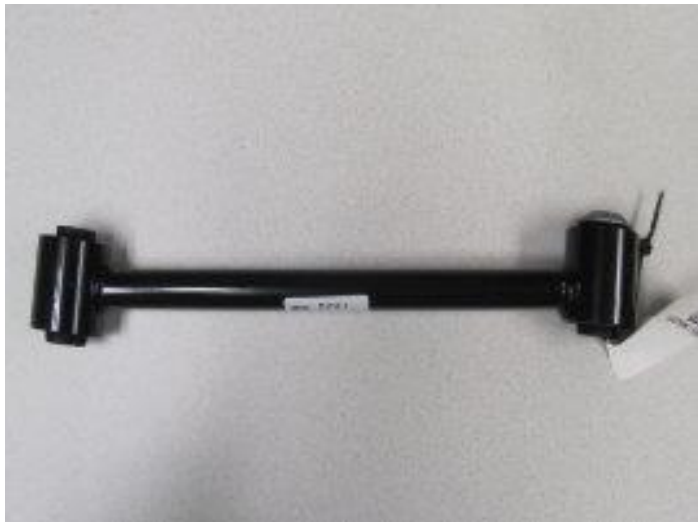
5903821

Solid link service part
