Product Safety Recall

N212329840 Engine Heater Short Circuit

Release Date: March 2022

Revision: 02

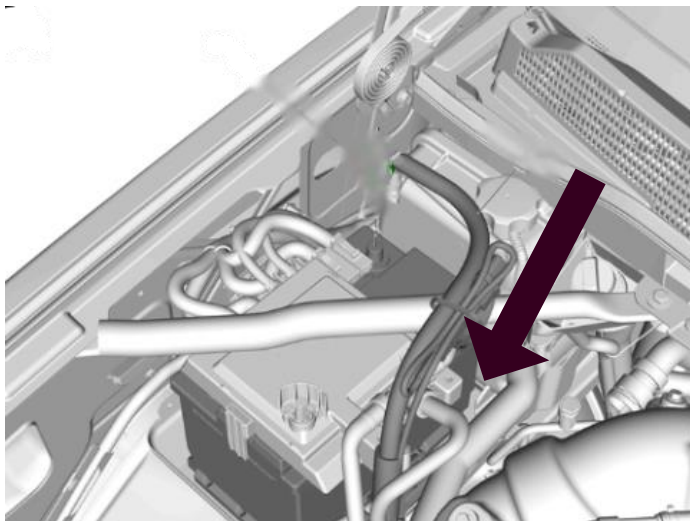
5946406

- Start lowering the cord inboard of the battery toward the front of dash.

2. Locate and remove all of engine compartment power cord attachment points.
3. Drop the existing power cord to the underside of the vehicle.
4. Remove the new service engine heater power cord from the box and uncoil the cord.
5. Lower the engine heater element end of the new power cord to the underside of the vehicle.

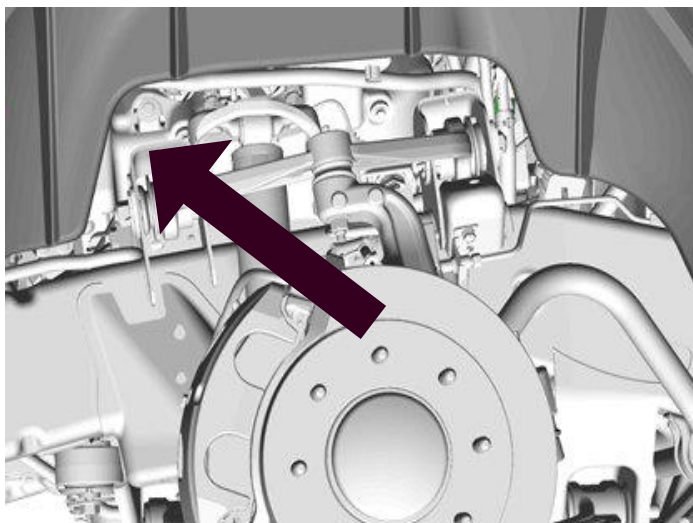
5946404

- It should come out in the area identified above.
6. Raise the vehicle and remove the right front wheel. Refer to *Tire and Wheel Removal and Installation (8-Lug Wheel)* in SI.
 7. Remove the right front wheelhouse liner. Refer to *Front Wheelhouse Liner Replacement - Right Side* in SI.

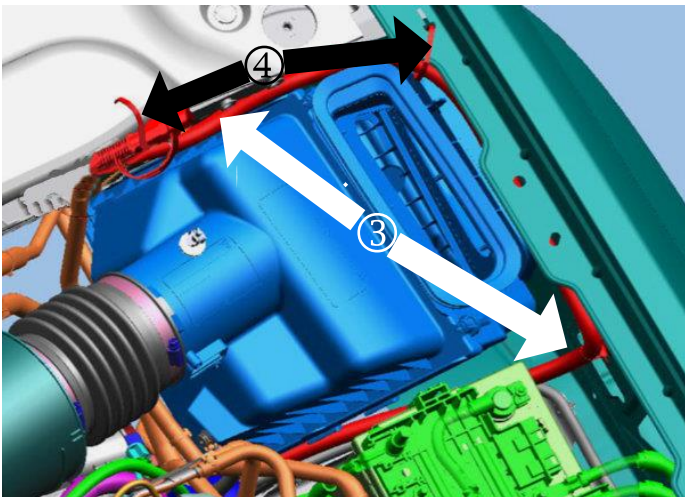
5946413

Push pin attachments (3), wire tie attachments (4).
