Product Safety Recall

N202324251 Roof Rail Air Bag Inflator May Rupture

Release Date: July 2022

Revision: 04

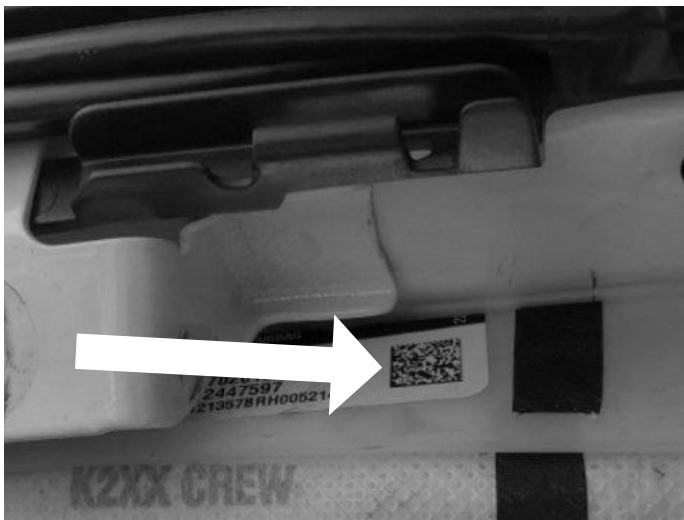
6058834

Record the serial number on each of the white airbag labels.

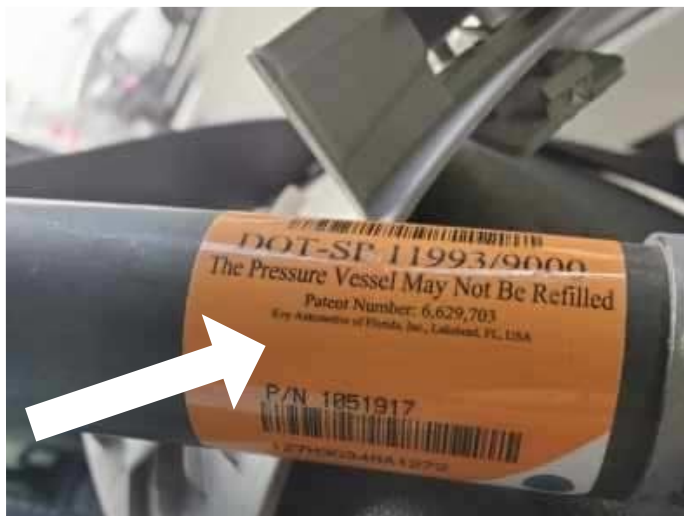
6058836

Do Not record the serial number (orange label) on the inflator.

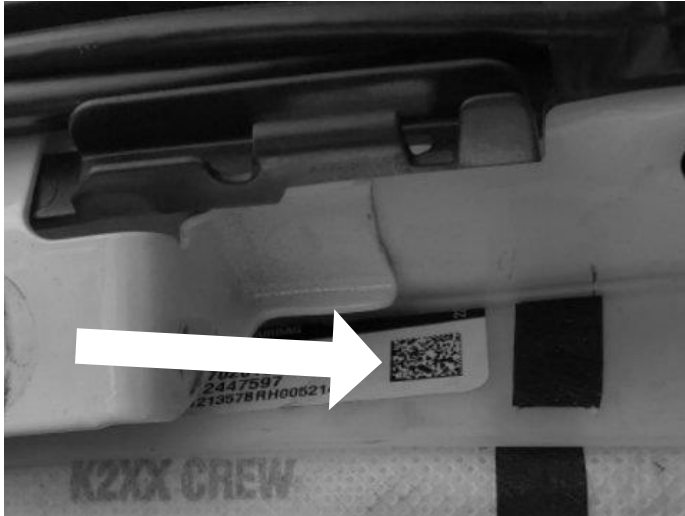
6058834

Record the serial number on each of the white airbag labels.

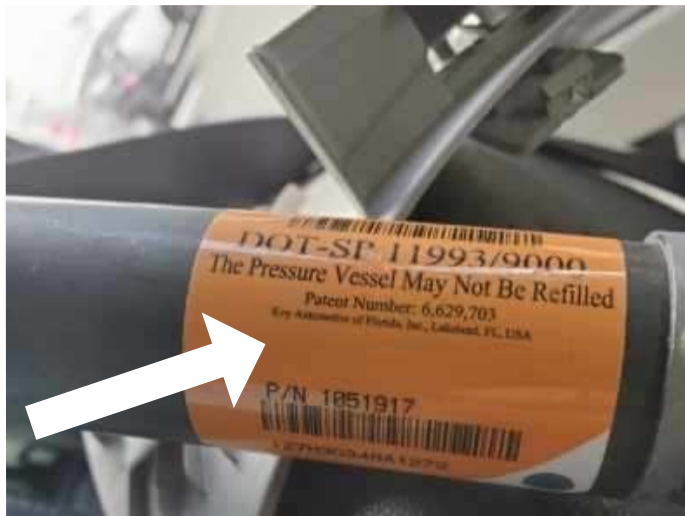
6058836

DO NOT record the serial number (orange label) on the inflator.
