Product Safety Recall

N202324251 Roof Rail Air Bag Inflator May Rupture

Release Date: June 2022

Revision: 03

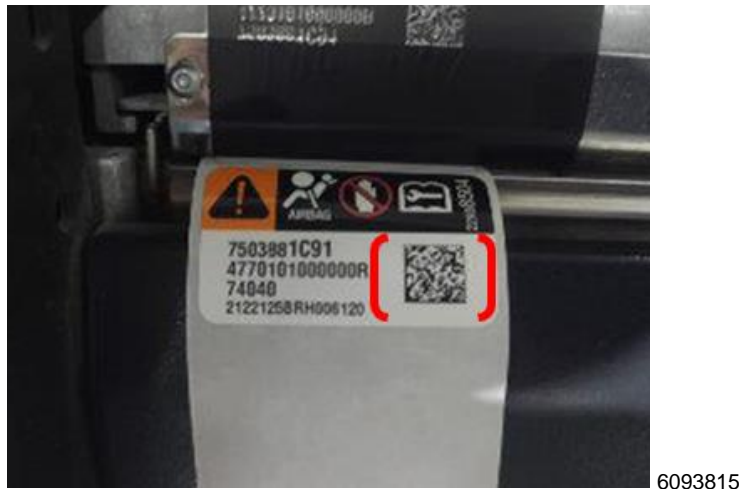
Please center ONLY the QR Code within the Red Brackets as seen below. If the scan function is inaccurate, please use the guide below for entering the information manually into the RPT fields.

From the recall example photo above:

Part Number: 7503881C91

VPPS: 4770101000000R

DUNS: 74040

Traceability Number: 21221258RH006120

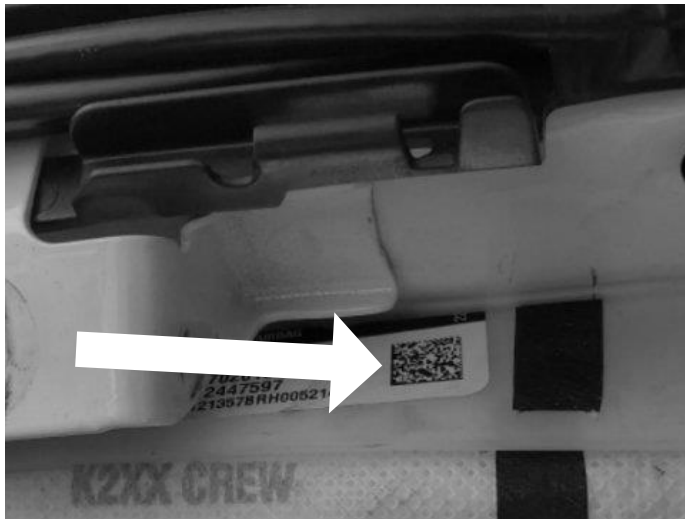
6058834

Record the serial number on each of the white airbag labels.

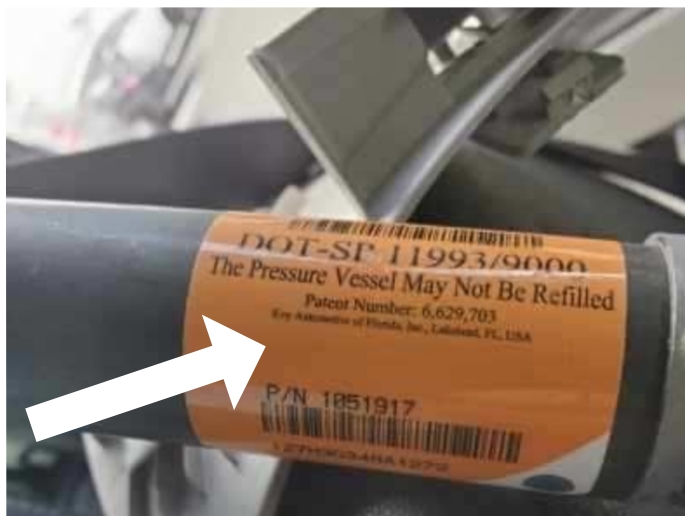
6058836

DO NOT record the serial number (orange label) on the inflator.
