Product Safety Recall

N202324251 Roof Rail Air Bag Inflator May Rupture

Release Date: May 2022

Revision: 02

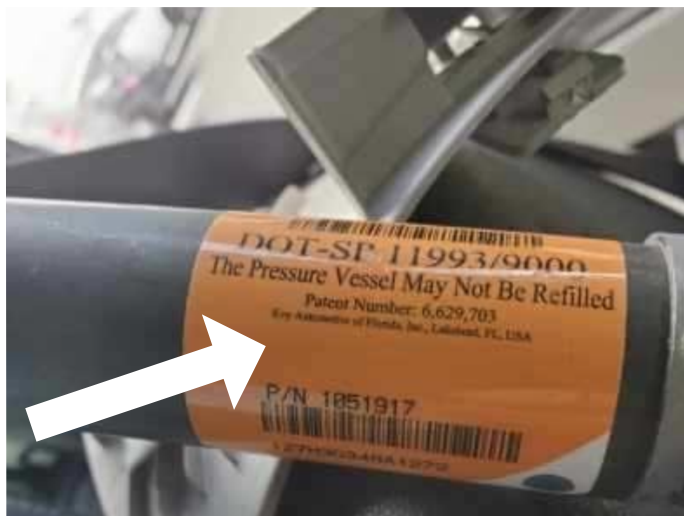
6058836

Do Not record the serial number (orange label) on the inflator.

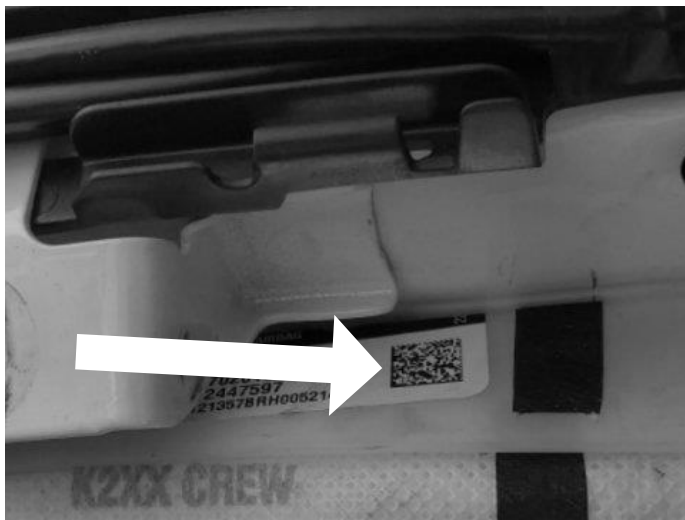
6058834

Record the serial number on each of the white airbag labels.
