Product Safety Recall

N202324251 Roof Rail Air Bag Inflator May Rupture

Release Date: May 2022

Revision: 01

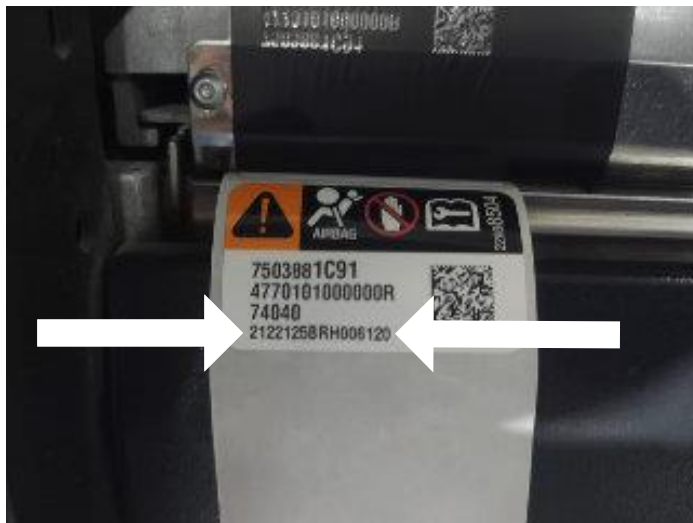
6070604

IMPORTANT: * (TECHNICIAN and WARRANTY ADMINISTRATOR) SERIAL NUMBER RECORDING REQUIREMENT. The replacement left and right roof rail airbag assembly serial numbers must be captured by the technician and recorded on the job card. The Warranty Administrator **MUST** enter the replacement left and right roof rail airbag assembly serial numbers in GWM (Global Warranty Management) or in DMS (Dealer Management System). Enter the serial number of the **replacement RIGHT roof rail airbag** in the 'Labor Operation Dependency Code' field (1) per the screen above. Enter the **serial number of the LEFT roof rail airbag** in the 'General Comments' comments section. Failure to enter these serial numbers will cause the claim to reject.

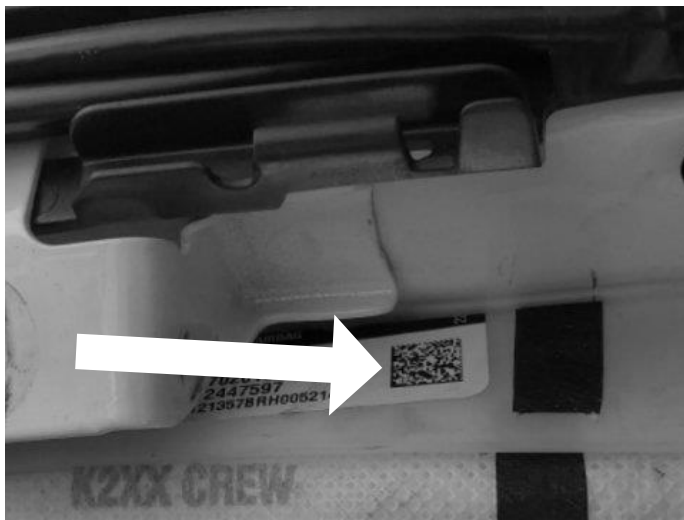
6058834

Record the serial number on each of the white airbag labels.

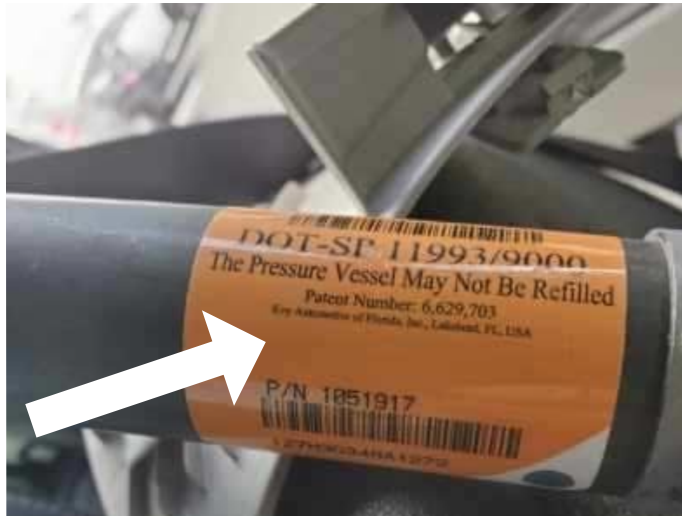
6058836

Do Not record the serial number (orange label) on the inflator.

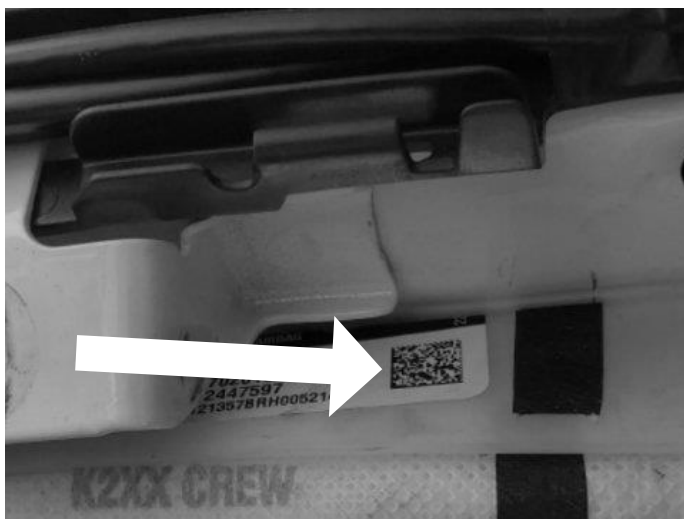
6058834

Record the serial number on each of the white airbag labels.

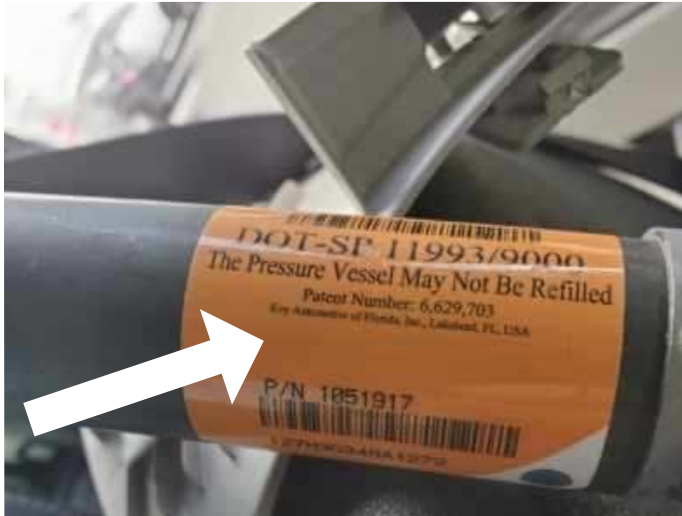
6058836

DO NOT record the serial number (orange label) on the inflator.
