# Product Safety Recall

## N212343883 High Voltage Battery May Melt or Burn

**Release Date:** December 2021  
**Revision:** 01  
**Revision Description:** The customer letter and 2017-2018 model year vehicles have been added to the bulletin. The programming steps of the service procedure in this bulletin have also been revised. Please discard all previous copies of bulletin N212343883.

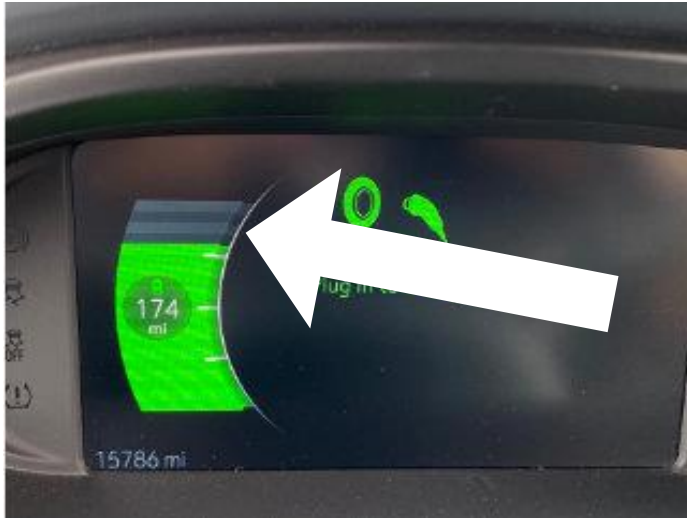
5924268

**Important:** Verify the vehicle SOC is less than 80%. This can be determined by looking at the bars on the power level indicator. If four or more empty bars (not showing green) are displayed, the SOC is at an acceptable level. If the power level indicator shows an SOC of greater than 80% The SOC must be adjusted before proceeding with the recalibration.

- Vehicle in PARK, Vehicle ON.
- Headlamps Low Beam: ON.
- Temp Control: Hi (Max Heat High) (note: windows should be down).
- Distribution: MAX Defrost (Engages AC Compressor).
- Fan Speed: High (8).
- Select: Fresh Air (Not recirc).
- Select: Heat & A/C .
- If equipped, turn heated seats to hi position.
- Verify SOC after 60 minutes. If the SOC is still greater than 80%, allow additional time for the loads listed above to reduce the SOC to less than 80%.
- When the SOC adjustment is completed return the HVAC controls to 72 Deg. AUTO, Set the headlamp control to AUTO.

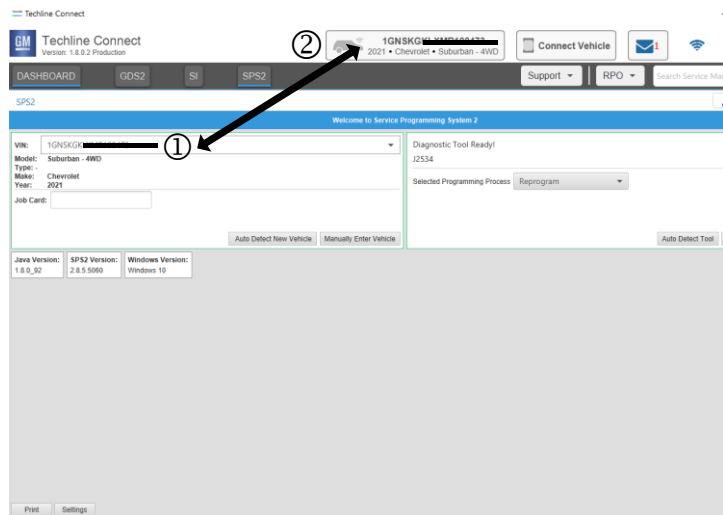
5743643

**Caution:** Be sure the VIN selected in the drop-down menu (1) is the same as the vehicle connected (2) before beginning programming.

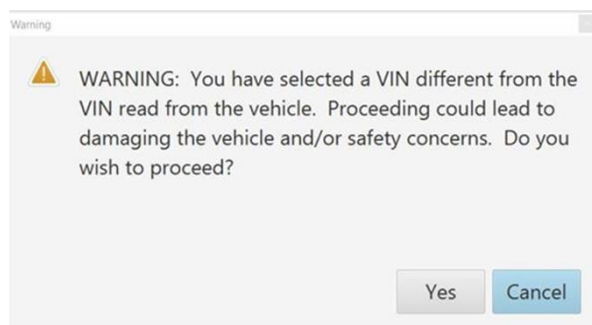
5877000

**Important:** If the vehicle VIN DOES NOT match, the message below will be shown.

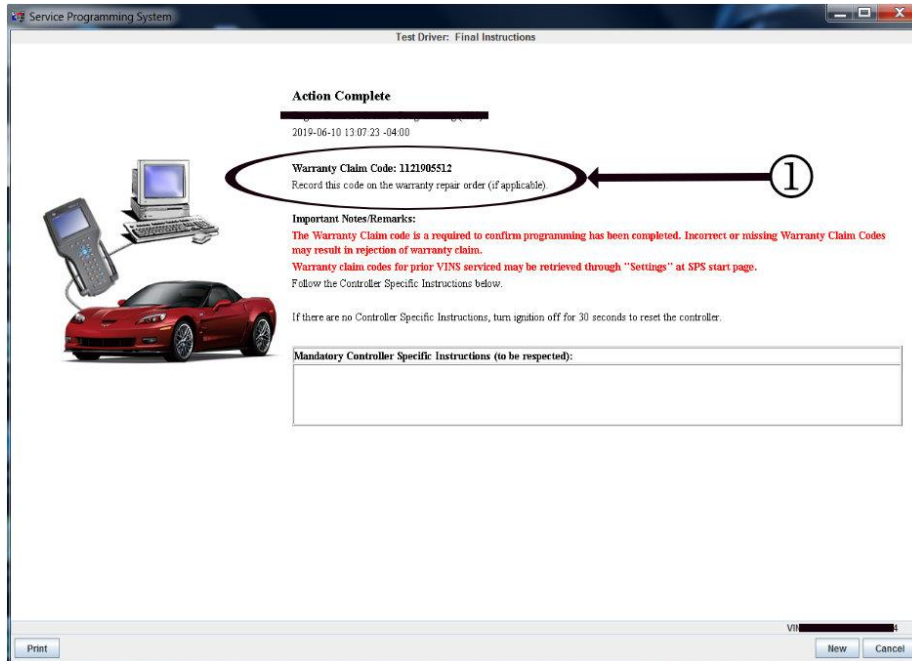
5431209

**Important:** To avoid warranty transaction rejections, you **MUST** record the warranty claim code provided on the Warranty Claim Code (WCC) screen shown above on the job card. Refer to callout 1 above for the location of the WCC on the screen.

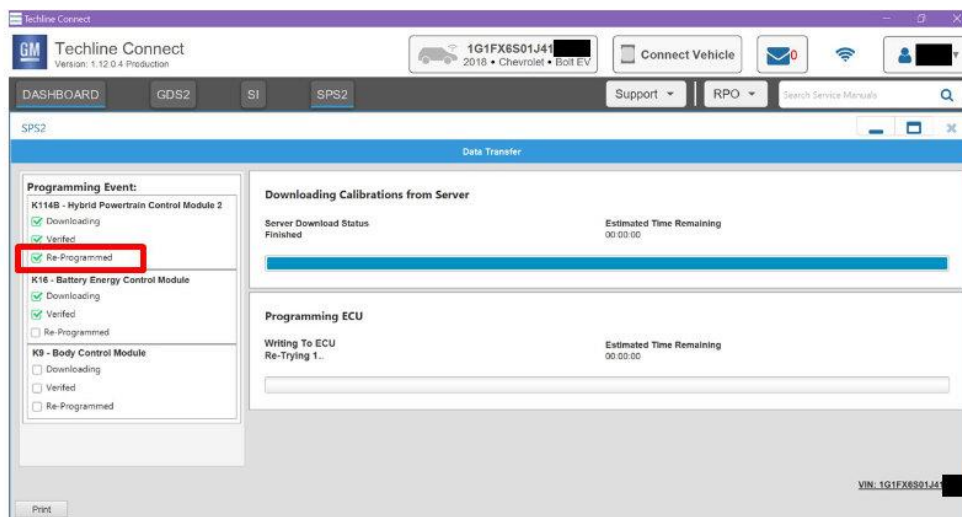
5924567

**Note:** The first module in the sequence is the K114B HPCM2 which is programmed with Ignition OFF and the brake pedal depressed to keep communications awake. The second module in the sequence is the K16 BECM, which is programmed with Ignition ON/Propulsion OFF. The third module is the K9 BCM is also programmed with Ignition ON/Propulsion OFF.

1. Reprogram the sequential multiple modules through SPS/Techline Connect (SPS and Techline Connect screens shown) by selecting **“ZFA – Field Action Multimodule Coordinated Sequence”** on the select controller screen and select **“Programming”** for the Select Function/Sequence”. Select **“Next”** and follow all on screen instructions. In SPS, scroll down to view all instructions prior to programming.
