Product Safety Recall

N212340970 Incorrect Software Calibrations May Affect Certain Driving Assist Features

Release Date: August 2021

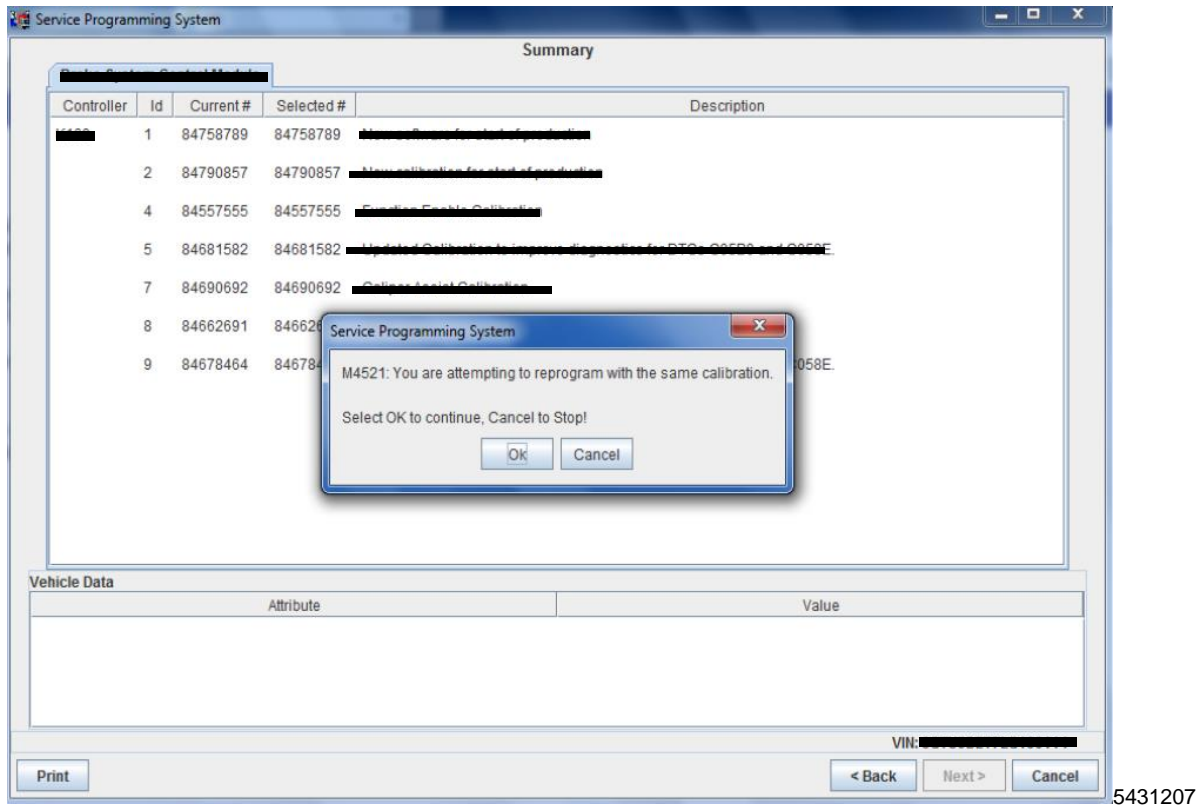
Important: Techline Connect and TIS2WEB screens shown above.

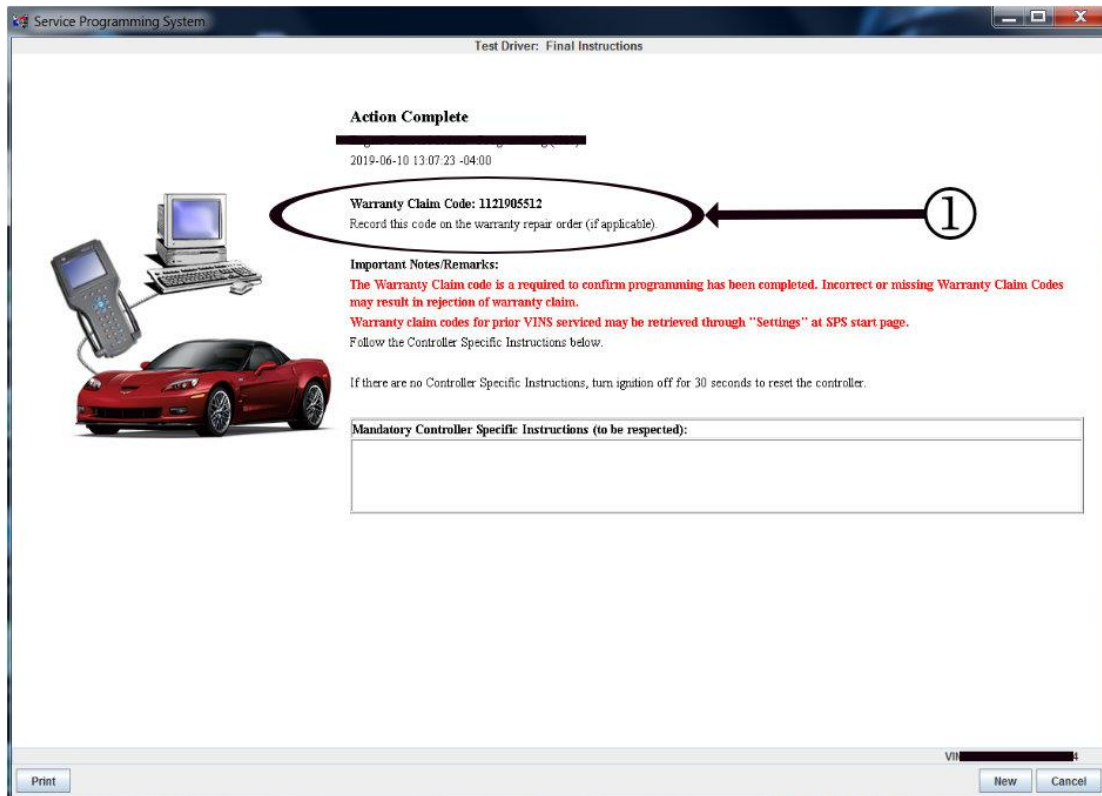
5431209

Note: The screenshots above are an example of module programming and may not be indicative of the specific module that is being programmed. Module selection and VIN information have been blacked out.

Important: To avoid warranty transaction rejections, you **MUST** record the warranty claim code provided on the Warranty Claim Code (WCC) screen shown above on the job card. Refer to callout 1 above for the location of the WCC on the screen.

2. Record SPS Warranty Claim Code on job card for warranty transaction submission.
