Product Safety Recall

N212342780 Improper Roof Rail Airbag Deployment

Release Date: September 2021 **Revision:** 01
Revision Description: This bulletin has been updated to add the customer letter. Please discard all previous copies of N212342780.

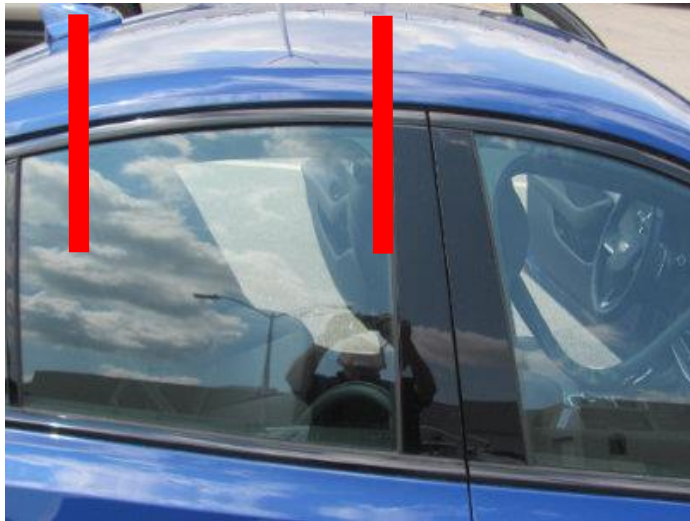
5879613

Inspection Area

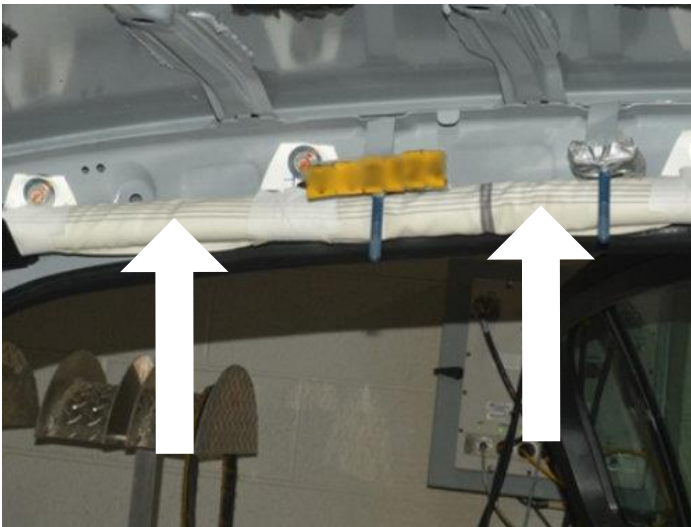
5879616

Good Example of Stitching

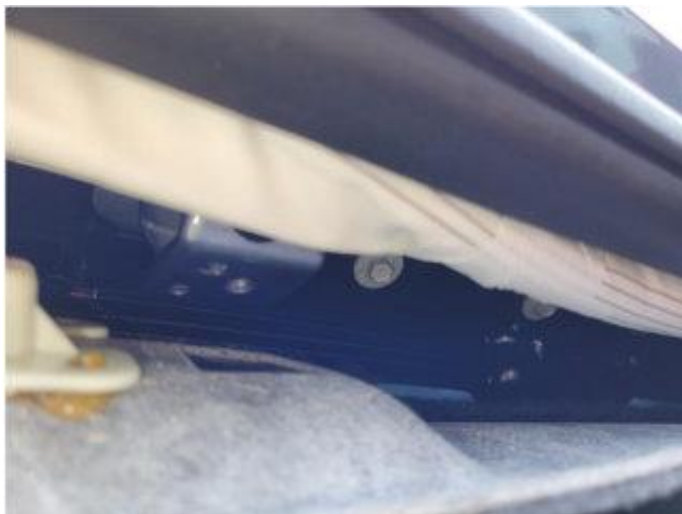
5879618

Unacceptable Example of Stitching 1

12. Remove all roof rail airbag push pin and threaded fasteners forward of the twist condition. Refer to *Front and Rear Row Roof Rail Airbag Replacement* in SI.
13. Straighten the twist condition using the black stitch lines for reference.
14. Reinstall the roof rail airbag push pin and threaded fasteners in sequence, from rear to front. Verify the black four-line stitching is straight and parallel after installing each fastener. Refer to *Front and Rear Row Roof Rail Airbag Replacement* in SI.
15. Reinstall the interior trim components and weatherstrips. Refer to the appropriate sections in SI.
16. Rearm the SIR system.

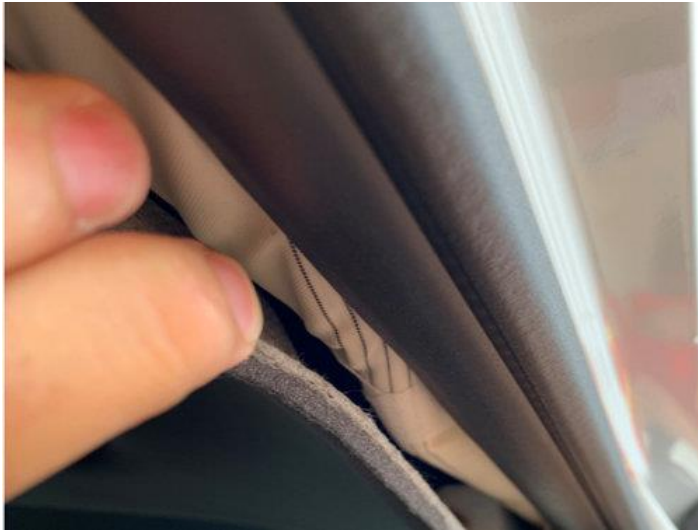
5879619

Unacceptable Example of Stitching 2
